Multi-Technique Approach for the Sustainable Characterisation and the Digital Documentation of Painted Surfaces in the Hypogeum Environment of the Priscilla Catacombs in Rome

In this paper, a multidisciplinary work carried out inside the Priscilla catacombs placed in Rome (Italy) is presented, focusing the analyses inside a particular decorated room named the Greek chapel. Here, several conservative problems due to the humidity were visible, requiring moisture mapping and, at the same time, accurate documentation of both structure and colour. A multi-technique approach was performed using different methods in a completely non-invasive way by combining instrumentation developed also for other applications, such as nuclear inspections. Five advanced instrumentations were employed in this work: a portable Nuclear Magnetic Resonance (NMR), an Audio Frequency–Acoustic Imaging (AF–AI) scanner, a fluorescence Light Detection and Ranging (LiDAR), an Infrared Thermographic camera, and a three-dimensional (3D) laser scanner. Such approaches allowed an evaluation of the moisture distribution as well as the presence of water-related effects such as structural damage and biological attacks. Th

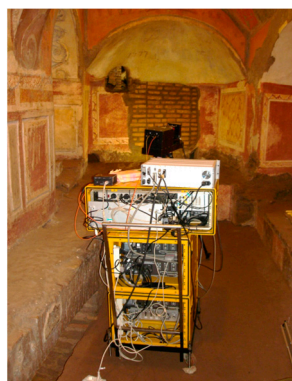
Figure 2. RGB-ITR scanner at work inside the Greek chapel.

The RGB-ITR system is an active method of 3D acquisition based on laser sources for the target digitalisation. This apparatus was developed by ENEA (the Italian National Agency for New Technologies, Energy and Sustainable Economic Development) for inspections and digitisation of long-range targets, also in critical and not easily reachable environments, such as nuclear reactors [17]. Over the last twenty years, the instrument was also used in the CH field for the study and documentation of decorated surfaces, such as paintings, frescoes, and coffins [18–20]. In particular, the RGB-ITR scanner allows to obtain 3D colour models of the scanned surfaces, also of large dimensions and/or at great distance. The technology of the system is based on the amplitude modulation (AM) technique of the laser sources [21,22], combined with the Lock-In detection [23], which can acquire signals also in noisy environments, estimating at the same time the amplitude and the phase shift of the signals coming from the target. The system is composed of two units: an optical head, consisting of a system of lenses and mirrors for focusing, steering, and acquiring both the incident laser beam and the back-reflected light; the electronic unit includes the elements for the optoelectronic signal conversion, data acquisition, and storage. The two modules are physically separated but connected by fibres for the emission of the launching beam and the collection of the back-reflected signals from the target. The laser spot is swept onto the target through a motorised mirror with a TV raster-like movement of the beam. The great advantages of using such a system are mainly the capability of remotely analysing either small or large objects, also at great distances, without scaffolding and without any influences of surrounding illumination, allowing to perform the scans also during the night. Indeed, with the use of the active approach provided by the use of laser sources instead of passive ones that use CCD sensors, the RGB-ITR 3D models are not affected by the ambient light, avoiding the most common camera issues such as glare and/or shadow effects [24]. The acquisition and the post-processing procedures are controlled by custom tools developed in the MATLAB 2024 environment, namely ScanSystem and itrAnalyzer, respectively. The first software allows the configuration of the scanning parameters (area, resolutions, timing, and more) and runs the acquisition; the second one consists of image processing algorithms for the elaborations of the images from the reflectance data, improving the mapping quality and post-processing images, which can be exported in the most common file formats. Since the complexity of the Greek Chapel architecture consisted of several niches, the complete colour digitalisation was obtained in eight working days, moving the instrument to four stations within the room. The instrumentation was installed in the tower configuration with the optical head mounted on a tripod (Figure 2). The acquisition resolution was differentiated on the basis of the importance of the scanned element, as indicated by the conservators: higher scanning speed and lower resolution (0.004°) for the low and sparsely decorated parts of the chapel; lower speed and higher resolution (0.002°) for the most important decorations with greater iconographic relevance. Furthermore, the system worked also during the night hours in order to reduce the scans in the visiting time.

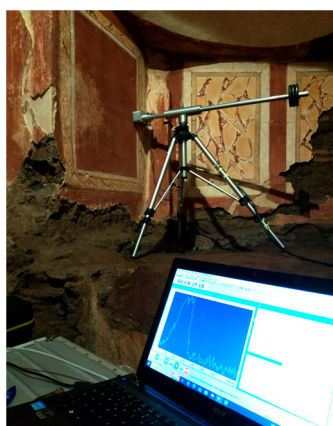
Figure 3. NMR system during the acquisition process.

In the study of masonry structure, the NMR technique is mainly adopted for water content evaluations. Indeed, in the NMR methodology, the intensity of the signal is directly proportional to the percentage of H atoms inside the masonry, making it easily linked to the presence of water [25]. In portable NMR sensors, the geometry of the magnet is defined as open geometry. In these sensors, the magnetic field is generated using two anti-parallel permanent magnets mounted on an iron yoke with the radio frequency (RF) coil positioned in the gap. By tuning the RF, the depth or the distance to the sensor surface where the sensitive volume is generated can be shifted. By optimising the magnet and the RF coil geometries, a flat, sensitive volume can be generated at a variable distance from the sensor surface. In this configuration, the magnetic field is external to the device and allows us to non-invasively study large objects by placing the sensor on one side of the object. In the Greek Chapel, NMR measurements were performed with a portable NMR instrument from Bruker Biospin (Figure 3), operating at 16 MHz and at a depth of 0.5 cm from the surface, fully disregarding the signal from the surface. The maximum echo signal corresponding to a $\pi/2$ pulse was obtained with a pulse width of 10.4 μs and a deadtime of 15 μs .

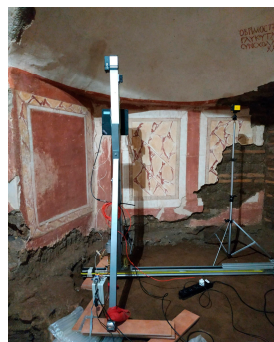
Figure 4. AF–AI system working inside a niche of the Greek chapel.

In the Greek Chapel, a highly directive acoustic source (20 cm × 20 cm) Audio Spotlight by Holosonics was employed, delivering a narrow sound beam towards the examined surface. The omnidirectional i436 Class 2 measurement microphone by MicWaudio, with −44 dB (6.3 mV/Pa) sensitivity, measured the amount of reflected acoustic energy using a back reflection geometry. A PC remotely controlled the motion control unit (The motion control unit is assembled by Tecni.com S.r.l. (Frascati, Italy) using UNILINE linear guides by Rollon S.r.l. (Vimercate, Italy)) and the National Instruments USB6221 (USB6221 acquisition board by National Instruments (Austin, TX, USA)) acquisition board through custom software. Figure 4 shows the ACEADD system during the on-site measurement in the Greek Chapel. During a first campaign, three rectangular regions were analysed, collecting vertical profiles 80 cm high along the central axis and a few lateral axes (from 10 cm to 30 cm distant). This procedure indicated a general representation of a significant portion of the chapel. During a second campaign, a more detailed image of one of those regions was obtained, providing an accurate indication of the state of conservation of that portion. In the present investigation, the IAI images were considered for all the investigated areas, and a more detailed insight by means of FRAI images was conducted for one area. The measurements were carried out at a constant temperature of around 16 °C and 100% relative humidity.

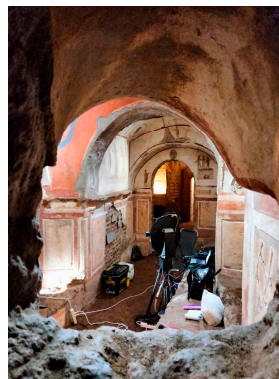
Figure 5. LIFART system working inside a niche of the Greek chapel.

The LIFART system (Figure 5) uses a laser source to generate a coherent and collimated light beam; the 266 nm Nd:YAG laser emits pulses lasting 8 ns with a repetition frequency of 20 Hz (ULTRA 30 Quantel). The beam sent onto the surface under study interacts with the surface layers and causes various phenomena. In particular, materials susceptible to fluorescence absorb part of the laser energy and subsequently emit light at a higher wavelength (lower energy). An optical receiver collects the fluorescence light by means of an objective (70 mm $f\#4$) and disperses it by a fixed grating spectrometer (Horiba CP-140) with an entrance slit of 0.1 mm. The optical signal is finally sent to a sensor (model ANDOR ICCD DH734-18) sensitive between 250 and 800 nm with a total spectral resolution of approximately 5 nm. The optical sensor is equipped with an intensifier controlled by a time gate whose function is to measure the fluorescence emitted exclusively during the time interval of the time gate, while light outside this interval is ignored. The gate has a minimum duration of 2 ns and a delay between 0 and 10 μs . For the current experimental

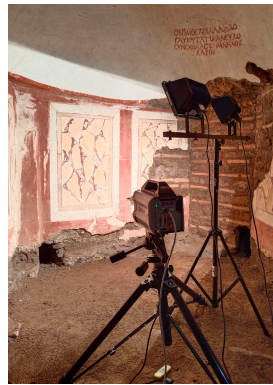
Figure 6. Thermographic apparatus working in the chapel.

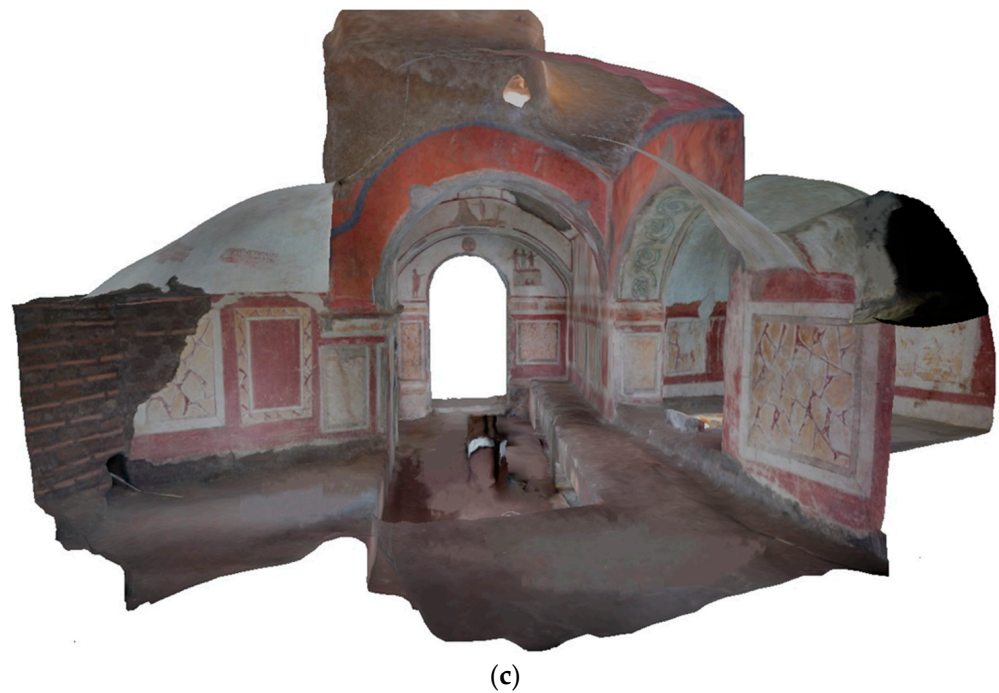
Figure 7. Three-dimensional model of the Greek chapel obtained with the RGB-ITR laser scanner: (a) view of the mesh where the room geometry is clearly visible and the investigated area is indicated; (b,c) sections of the model where all the room can be viewed and the accurate colours of the texture allow to better appreciate the paintings.

The elaborations of the RGB-ITR reflectance data with the custom software *itrAnalyzer* allowed to obtain the accurate 3D model of the entire Greek chapel. The complex geometry of the room was completely digitalised, as can be seen in the mesh reported in Figure 7a. As mentioned in Part 3.1, neither shadow nor illumination aberration affects the laser scanner data, achieving the colour-calibrated texture of the entire scanned surfaces. Thus, despite the scarce and yellowish illumination of the room at the moment of the scanning procedures, the RGB-ITR 3D model is characterised by accurate colours, enabling the high-quality digitalisation of the geometry of the room and its precious paintings (Figure 7b,c). This important result provides a useful tool for future restoration actions and for documentation purposes, being the recording of the actual conservative status. Furthermore, the high resolution of the model permits contactless analysis of every detail of the painted surfaces, providing a sustainable monitoring method since it does not require expensive software nor continuous acquisitions.

The 3D model was also used for better contextualising within the room structure the focused NMR, AF–AI, LIF, and IRT measurements. The areas investigated with the different techniques are reported in Figure 8: such areas were chosen following the suggestion of the restorers and curators of the catacombs, who indicated the areas as particularly delicate and frequently restored, evidently corresponding to a critical zone of the catacombs (A1, B1, C1).

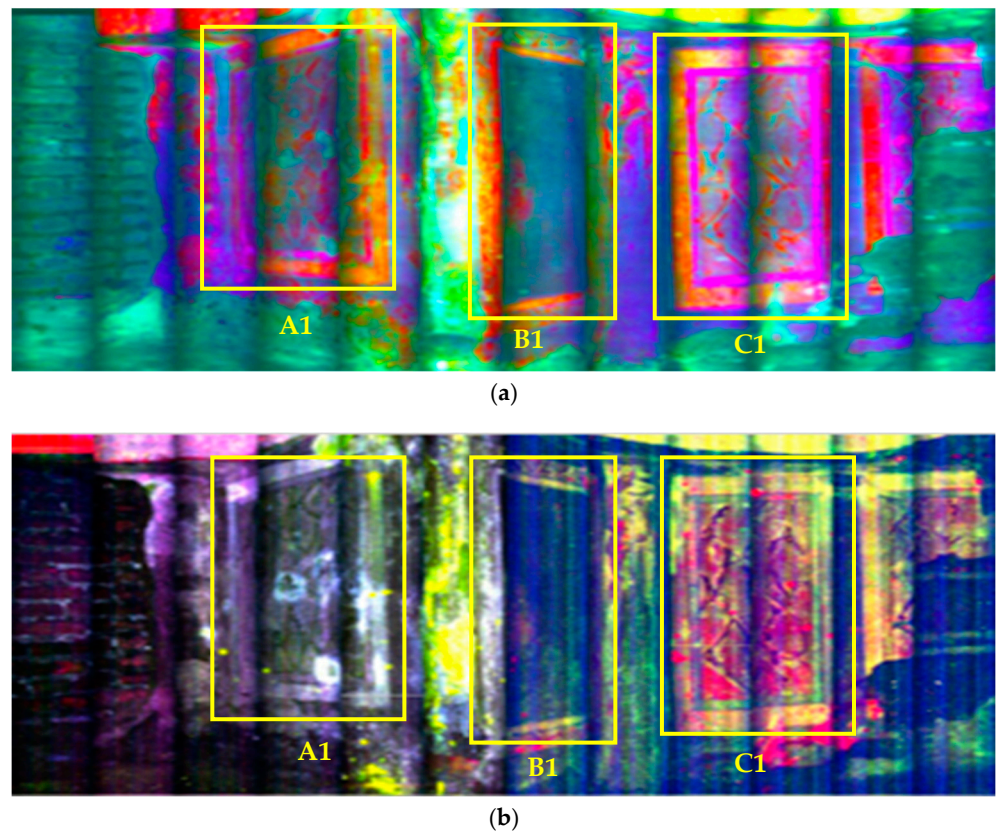
Figure 13. LIF results in correspondence of areas A1, B1, and C1, acquired (a) at zero delay and (b) at 30 ns delay from the laser pulse.

delayed fluorescence image, are attributed to the emission of materials originally located in deep subsurface layers. These materials appear on the surface due to decoherence phenomena, a process driven by the very high humidity of the hypogeal environment that occurs when the superficial wall structures are subjected to stresses from erosion, abrasion, or chemical reactions, and the surface material begins to lose its structural integrity. Due to this degradation, the materials located in the underlying layers, originally hidden and protected by the surface, become exposed. The deterioration highlighted by the LIF image is indicative of areas where there is significant removal of the surface layer and the presence of microfractures and discontinuities.

This result is not contradictory with the surface deterioration highlighted by the delayed LIF image shown in the right side of Figure 13, since the observed intraseasonal stability in the hypogean environment is compatible with local dynamics of moisture movement within the masonry wall, as evidenced by the NMR and comparative NMR-AI analyses.
