Article

Performance of Protection Devices Integrated into Lithium-Ion Cells during Overcharge Abuse Test

Energies **2024**, *17*, 4785. <https://doi.org/10.3390/en17194785>

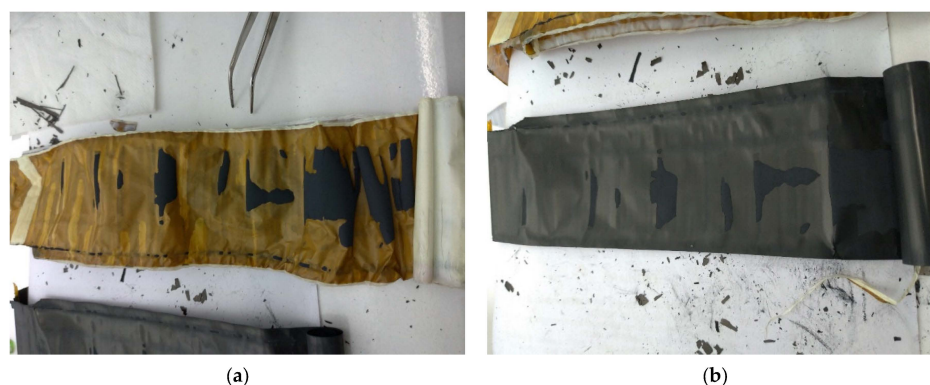
Figure 4. Disassembled cell: (a) separator (b) cathode.

In addition to the electrical measurements, physical observation of the electrodes by a Scanning Electron Microscope (SEM), JEOL JSM-5510LV, JEOL, Tokyo, Japan, was performed both on an overcharged cell and on a new reference cell to investigate the morphological changes on the electrodes surface. To this end, the two cells were completely disassembled to isolate the jellyroll from the remaining parts of the cells: the cap, the case and the protection devices (CID and PTC). Afterward, the active components of the cell were unrolled and separated. Figure 4 shows the separator, and the cathode layered on the aluminum collector.

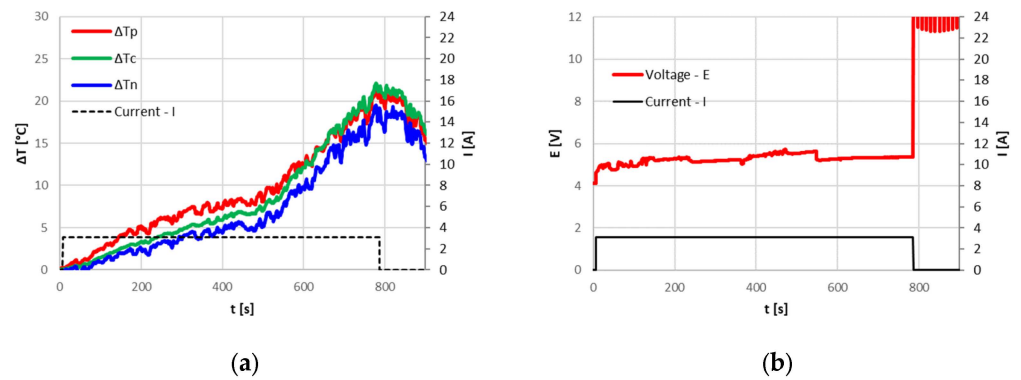
Figure 6. Unprotected cells. Overcharge test with a constant current of 3.2 A (1C) in open air: (a) temperature difference and current of the abused cell; (b) voltage and current of the abused cell.

The previous graphs also demonstrate that, for higher currents, the temperature at the positive terminal rises more markedly than that at the center of the cell and at the negative terminal. As it will be discussed in the subsequent paragraphs, the presence of the CID and the PTC increases the resistance at the cell top, causing a greater energy dissipation than in other parts of the cell, as already found by Menale et al. [24] by thermal infrared camera measurements (Figure 8).

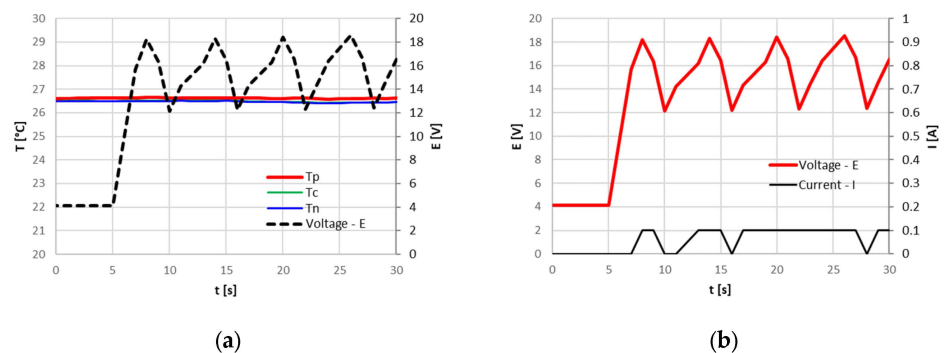
Figure 12. Protected cells. Overcharge test with a target current of 3.2 A (1C) in open air: (a) temperature and voltage of the abused cell; (b) voltage and current of the abused cell.

Both the attempts to overcharge the cell from 100% SOC, the first one with a current of 9.6 A (3C) and the second one with a current of 3.2 A (1C), resulted in the immediate PCB intervention that cut off the circuit, pushing the cycler voltage at its limit of 18 V, as shown in Figures 11 and 12. In these cases, the target current was never achieved due to the fast response of the PCB device.

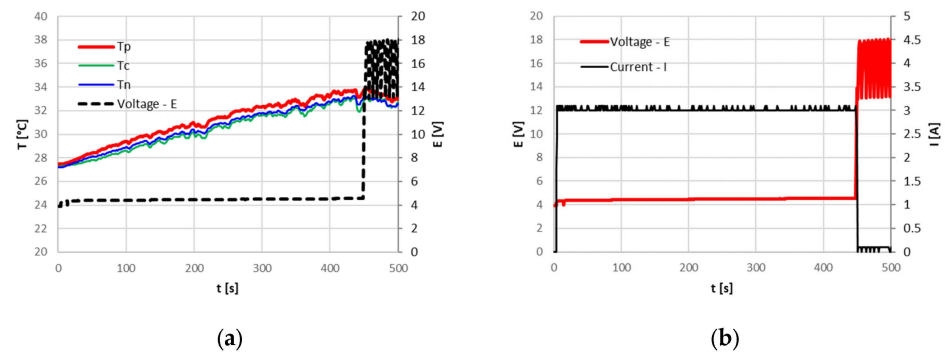
Figure 13. Protected cells. Overcharge test with a target current of 3.2 A (1C) in open air after discharge at 80% SOC: (a) temperature and voltage of the abused cell; (b) voltage and current of the abused cell.

In the last test, the cell was discharged at 80% SOC with a current of 3.2 A (1C) and then charged with a current of 3.2 A (1C), as shown in Figure 13. Charging ends when the cyclers reaches 4.55 V. The constant current mode of charging results in less charge accumulated by the cells with reference to the CC-CV charge used for the cell initial cycles, probably because the PCB intervention is based on voltage limits.

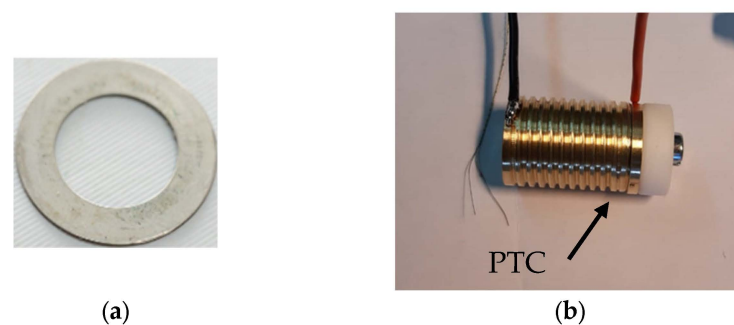
Figure 18. Positive Temperature Coefficient (PTC) analysis. (a) PTC device; (b) brass cylinder with PTC inserted.

The PTC (Figure 18a) was extracted from the cell during the cell disassembly described in Section 2.1 for the extraction of the jellyroll. To test the resistance of the PTC, the device was inserted into a metallic solid cylinder (Figure 18b) to have the current flow through all the PTC area. The cylinder is made of brass, and its purpose is to mechanically simulate the cell.

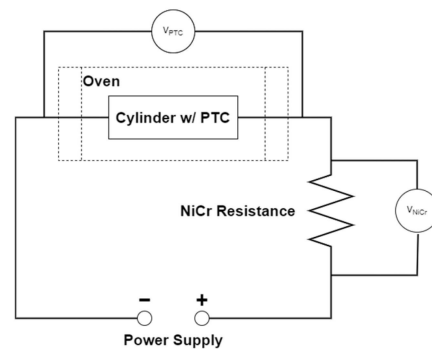
Figure 19. PTC analysis. Test circuit scheme.

The cylinder was then inserted into a circuit, where the current was supplied by an external power source (maximum voltage 40 V; maximum current 5.5 A), including an additional resistance in nickel chromium alloy (NiCr), with a value of $0.430\ \Omega$ at $35\ ^\circ\text{C}$. Due

The scheme in Figure 19 shows the layout of the circuit used. Voltage was measured across the brass cylinder-PTC assembly and across the NiCr resistance. The voltage across the NiCr resistance was measured to monitor the current. A thermocouple type K (accuracy ± 0.1 °C) was also mounted on the resistance to improve the current measurements at varying temperatures. Another type K thermocouple (accuracy ± 0.1 °C) was mounted on the brass cylinder to monitor the temperature of the PTC.

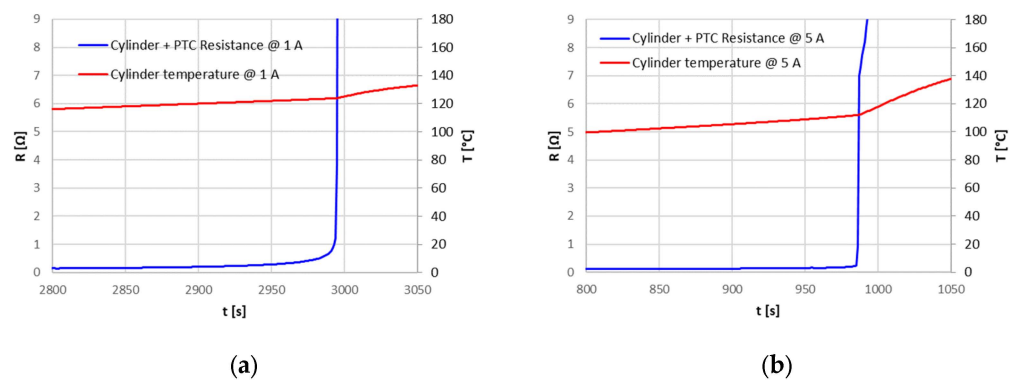
Figure 21. PTC analysis. Resistance and temperature of brass cylinder with PTC: (a) test performed at 1 A; (b) test performed at 5 A.

In this case, the measured resistance of the PTC ranged from 160 Ω to 115 Ω with a slight temperature increase: from 138 $^{\circ}\text{C}$ to 145 $^{\circ}\text{C}$ (Figure 22a). Furthermore, with an almost constant temperature of 145 $^{\circ}\text{C}$, the resistance continued to decrease, reaching a value of 90 Ω . It is supposed that the resistance at the triggering point could reach values above 160 Ω , and then start to decrease to a lower value even if the temperature increased or remained constant.
