Structural assessment of the pedestrian bridge accessing Civita di Bagnoregio, Italy

Abstract

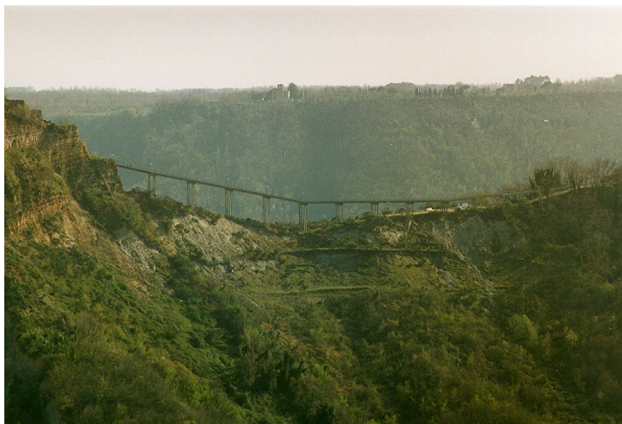
Fig. 1 Global view of the bridge (Civita is on the left)

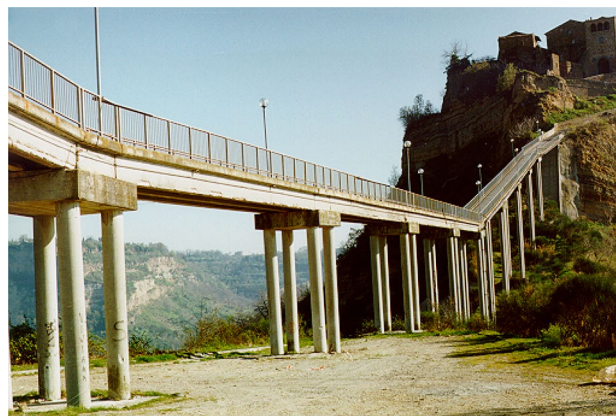
The present bridge comprises 14 spans, each one of them simply supported on the piers (Fig. 2), spaced approximately 19.00 m. Starting from Civita, five spans are located on a 20% gradient downhill. The heights of the piers from pier 1

Fig. 2 View of the bridge

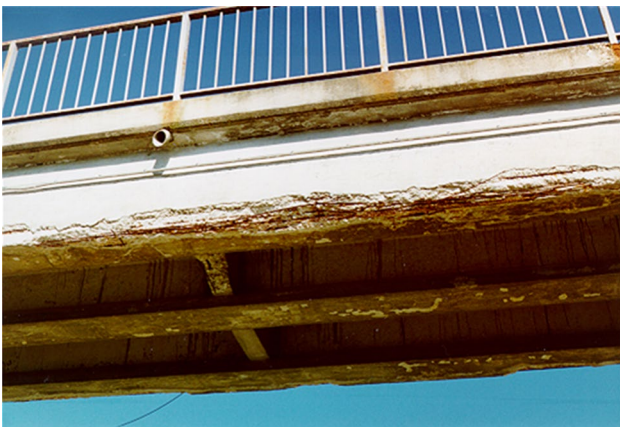
At the time of the inspection, most of the structural elements were in bad condition, because of different issues, including: corrosion of the reinforcing steel; spalling of the concrete; and carbonation of the concrete in some elements. The effects were particularly evident for the external beams, where the combined action of rain and wind was favored by the presence of short water drain hoses (Fig. 4). Steel reinforcing bars were also exposed at the zone close to the bearings (Fig. 5).

Fig. 4 The carbonation of the concrete and the reinforcing bar exposed

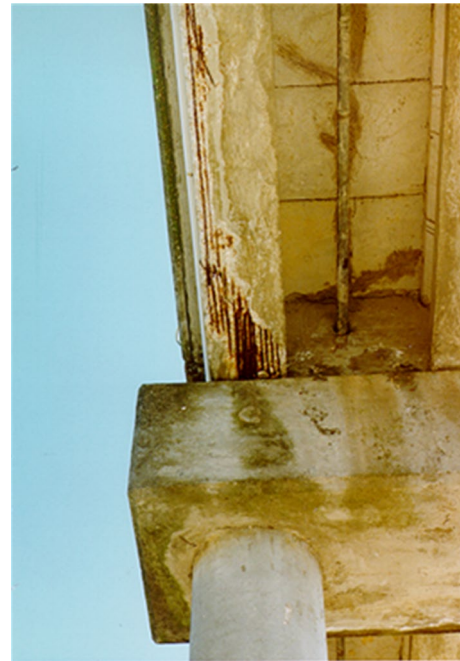
Fig. 5 Reinforcing bar exposed in proximity of the support

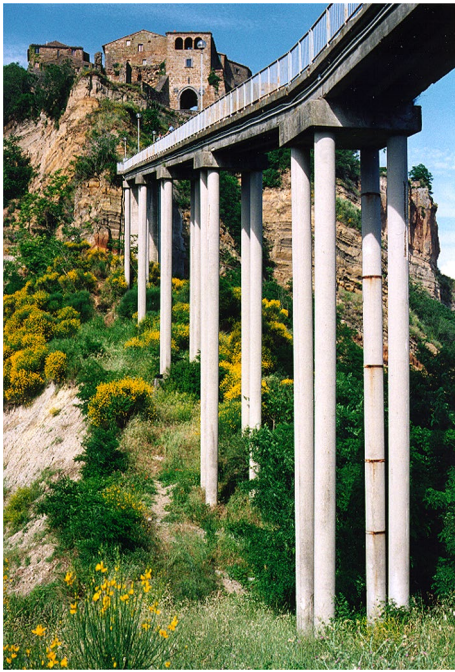
Fig. 7 The tallest part of the viaduct, from piers 1 to pier 5

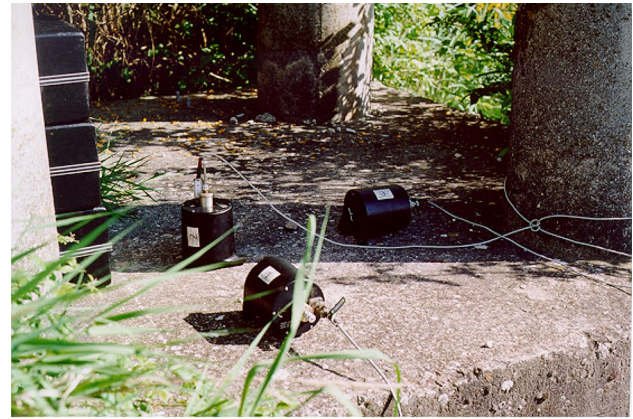
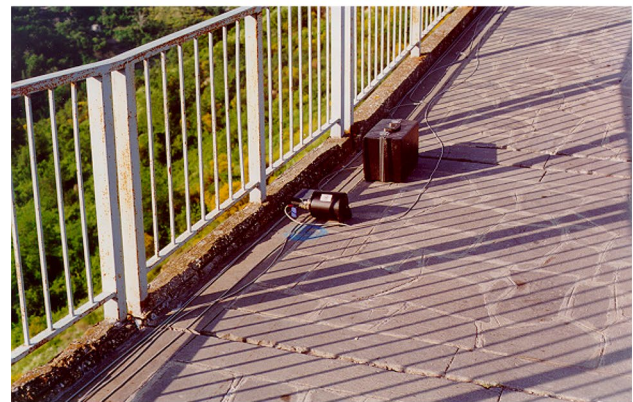
The experimental set-up was composed of eight seismometers Kinemetrix SS1 (Fig. 8a, b) connected by cables to a signal conditioner. The signals recorded by the eight seismometers, used in a synchronized way, were collected and analyzed in real-time to have control of the experimental results in real-time.

Fig. 8 Seismometer deployed (a) at the basement and (b) at the top of a pier

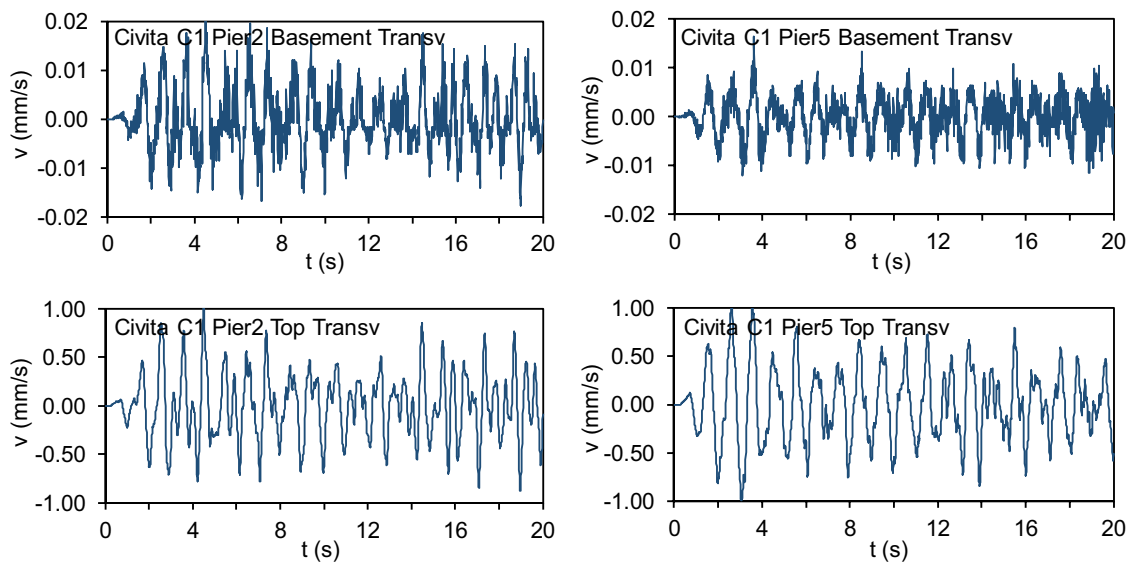
Fig. 13 Time histories at the basements and the tops of piers 2 and 5, in the longitudinal direction, under forced vibrations (C1)

During the passage of groups of pedestrians (forced vibrations), velocity peaks at the pile caps were lower than 0.03 mm/s, while the maximum velocities at the tops were between 0.5 and 1.5 mm/s (Fig. 13). In both cases, the amplification factors were between 20 and 50. The cross-spectra analysis confirmed the dynamic behavior of the bridge found under ambient vibrations (Figs. 14 and 15).
