Extending the life-span of cultural heritage structures

Paolo Clemente¹

Keywords Structural health monitoring · Experimental dynamic analysis · Cultural heritage

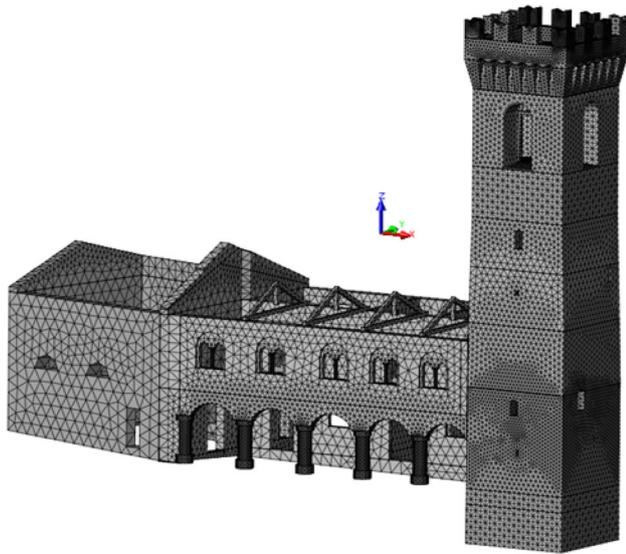
Fig. 1 The model of the *Podestà Palace* and the *Civic Tower* at Montelupone, Italy [25]

Clementi et al. [25], after an overview of the damage to cultural heritage structures occurred during the seismic events that struck Central Italy in October 2016, investigated the *Podestà Palace* and the Civic Tower located at Montelupone, in detail (Fig. 1). The main aim of the study was the determination of modal properties of these

historical masonry constructions using experimental and numerical studies. The experimental analysis was based on ambient vibration survey. The results were used to tune a numerical model of the structure, with solid elements, which was used in the finite element analysis. The modulus of elasticity of masonry and the interaction among the structural portions, which were considered the most doubtful parameters, were adjusted to obtain a suitable consistency between the experimental results and the numerical ones. The study revealed the actual dynamic properties of the damaged palace.

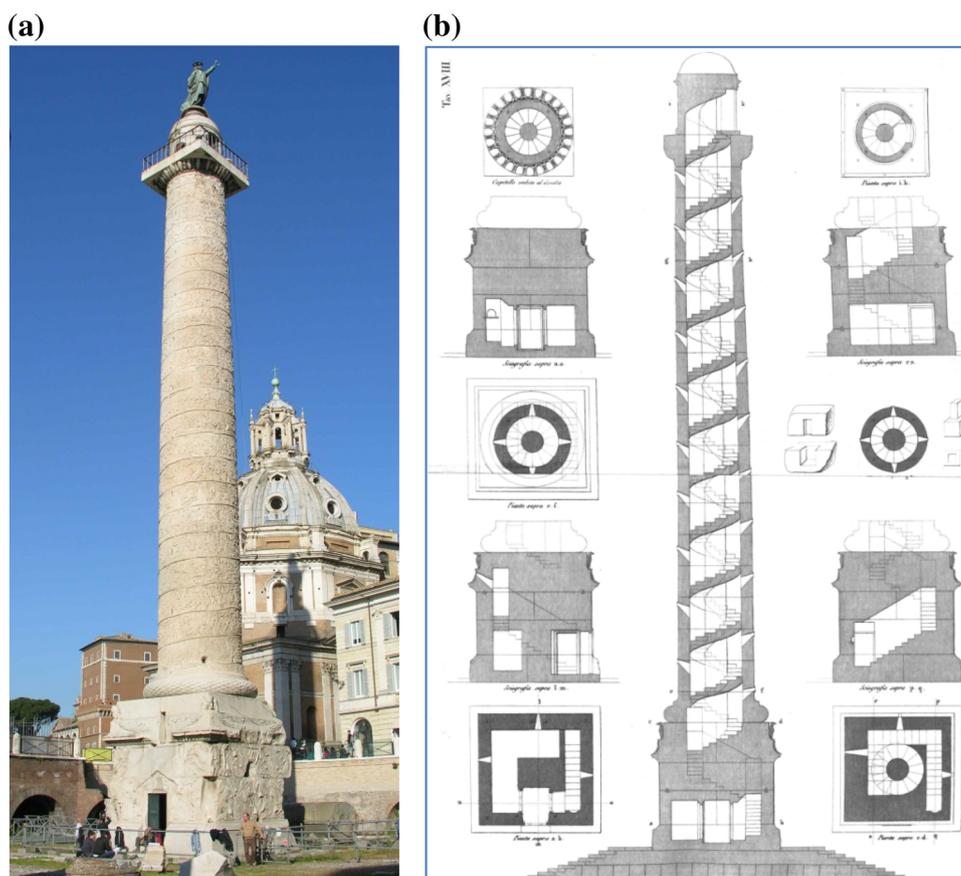
Fig. 2 Trajan's Column in Rome: **a** view and **b** Rondelet relief of the structure [26]

The paper by Bongiovanni et al. [26] faces the problem of the preservation of tower structures, reporting the results of the study carried out on the Trajan's Column in Rome (Fig. 2). It was designed by Apollodorus of Damascus as a commemorative monument and decorated with reliefs that illustrate the two military campaigns of the Roman Emperor Trajan in Dacia (the modern Romania), between 101 and 102, and between 105 and 106 A.D., respectively. The experimental vibration analyses of the column carried out first in June 1985 and then in March 2012, were analyzed and compared in time and frequency domains. In both cases the main resonance frequencies were found, pointing out their reduction in the second campaign with respect to the previous campaign. Usually, these can be justified by non-linear effects related to the amplitude of the external actions. Instead, in this case the presence in the second campaign of horizontal loads lower than those of the first campaign did not allow considering this justification. In the March 2012 campaign, recordings were acquired for almost one day, with a certain temperature variation. A usual reduction of the amplitude of the motion

was observed, but only a little variation of the main frequencies, which testifies a very little influence of the temperature on the dynamic behaviour of this structure.

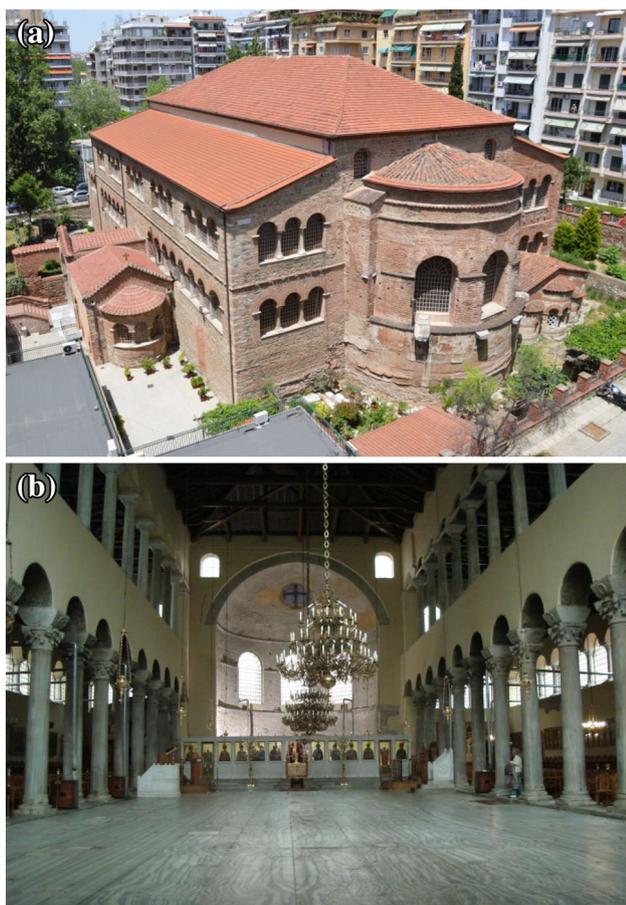
Fig. 3 **a** Southeast view and **b** internal view of the basilica Acheiropoietos [27]

Salonikios et al. [27] report the study of the Acheiropoietos basilica, an early Byzantine three-aisled timber roofed temple (Fig. 3), which suffered significant damage during the destructive earthquake of June 20th, 1978. Few years after the earthquake and before the interventions, ambient vibration measurements were performed on the structure and the main eigenfrequencies of vibration were obtained. The restoration project of the basilica, aiming to the provision of structural diaphragms at the level of the timber floors and roofs of the galleries, started at the middle of nineties. Horizontal steel frames were placed along the perimeter of the diaphragms at the wooden floors and wooden roofs. This intervention improved the seismic capacity of the temple. The efficiency of the intervention was checked by means of the analysis of the response of the structure to ambient vibration. The wooden diaphragms behaved as rigid floors, demonstrating that the intervention was implemented successfully.

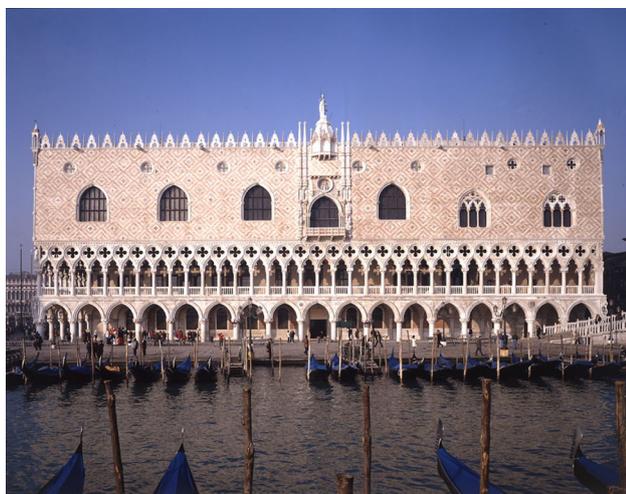
Fig. 4 *Palazzo Ducale* in Venice: the façade on San Marco basin [28]

Sciarretta et al. [28] present the results of the research and monitoring activities carried out at *Palazzo Ducale* in Venice, Italy, between 2009 and 2014 (Fig. 4). The aim of the study was to establish the structural health status of the two XIV-XV century external façades (South and West). The size of these façades, their complex and uncertain consistency, as well as their long and complicated history required a multidisciplinary approach with integrated and non-destructive methodologies. The diagnostics included the static monitoring of cracks and rotations, the dynamic monitoring along a critical vertical section, the sonic wave velocity measurements, the endoscopic probing and ground penetrating radar, the infrared thermographic imaging and the mineralogical and petro-physical analyses of stone samples. Other informations were obtained from visual and geometric surveys, bibliographic research and conventional calculations. The outcomes enlightened specific conclusions for each activity as well as crossing multidisciplinary points of view. These included the quality and consistency of the masonry, the stress state in the façade walls and the potentially critical issues. The study allowed optimizing the knowledge available. The results obtained could improve the scientific knowledge on the subject and support maintenance provisions for this unique and world-famous monument.

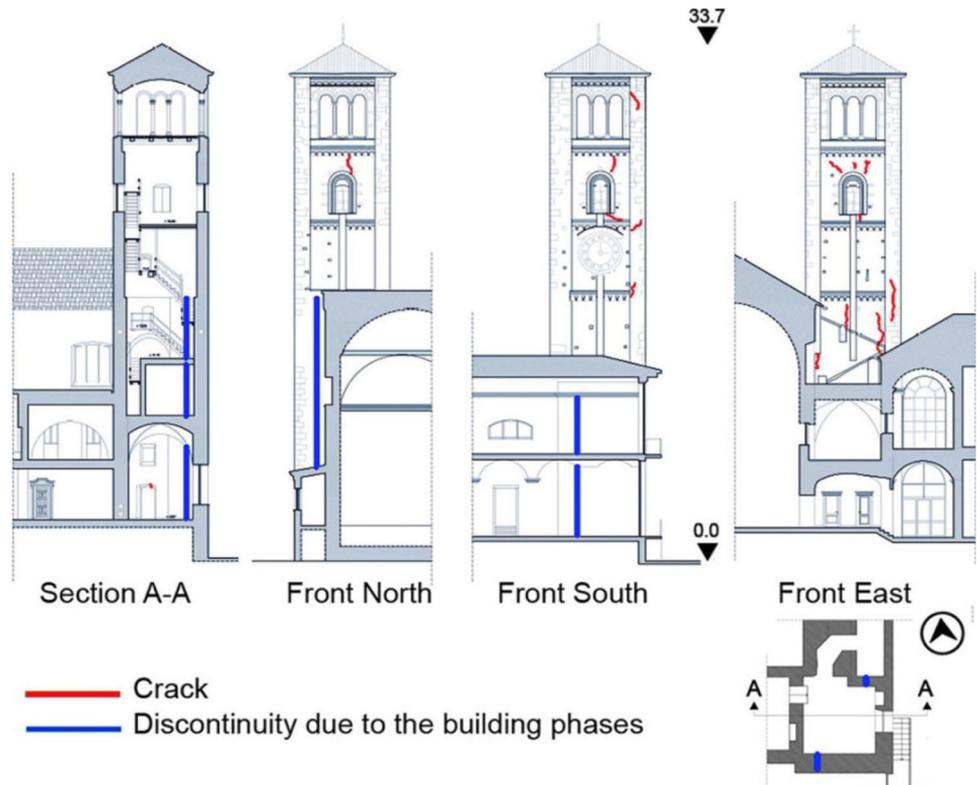
Fig. 5 Cross-section and fronts of the tower of *Santa Maria del Carrobiolo* in Monza, Italy [29]

The historic complex of *Santa Maria del Carrobiolo* in Monza (Fig. 5), Italy, is the subject of the paper presented by Saisi et al. [29]. The study highlighted first that two sides of the bell-tower are directly supported by the load-bearing walls of the apse and South aisle of the neighbouring church. Then, a network composed of 10

displacement transducers and 5 temperature sensors was installed in the tower to check the opening variation of the main cracks. Ambient vibration tests were performed and closely spaced modes with similar shapes were identified. Successively, a simple dynamic monitoring system was installed in the tower to complete the health monitoring aimed at the preservation of the historic structure. The paper focuses on the dynamic characteristics of the tower identified in the preliminary ambient vibration tests and on the main results obtained during 1-year dynamic monitoring. The effects of the temperature variation on the natural frequencies of the tower, which should be removed for an effective performance assessment, were assessed by means of simple correlation studies between modal frequencies and temperature.

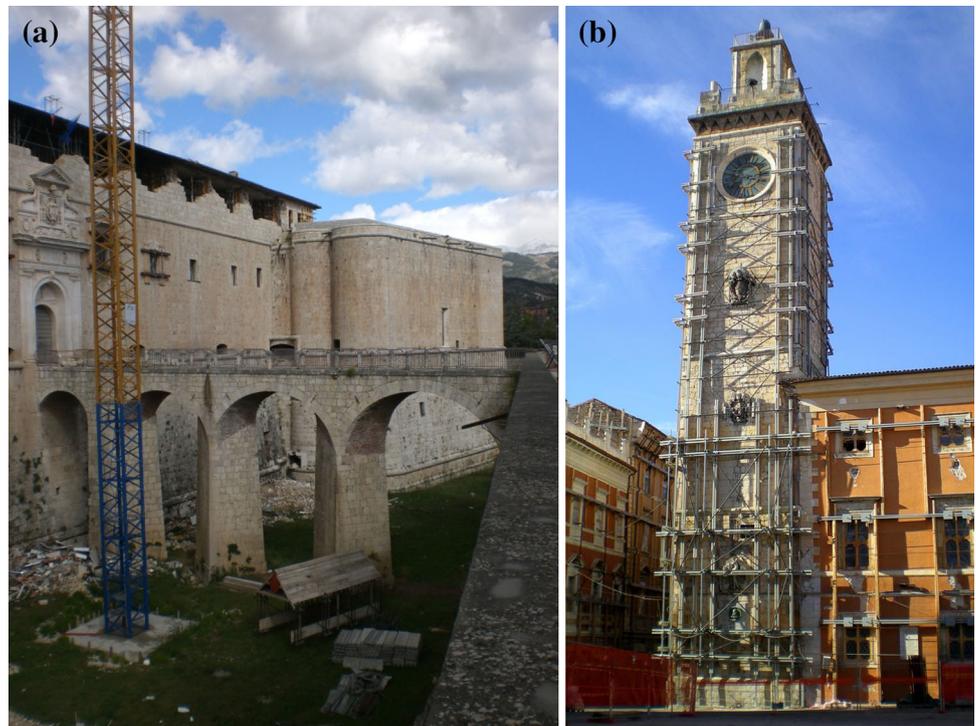
Fig. 6 **a** The Spanish Fortress and **b** the Civic Tower in L'Aquila [30]

interventions. The paper focuses on two case studies, i.e., the Spanish Fortress and the Civic Tower in L'Aquila (Fig. 6). The results of the preliminary investigations are reported, including damage survey and operational modal analysis, i.e., the identification of modal parameters using ambient vibration tests. Data acquired for 3 years by continuous monitoring systems were processed using a data-driven approach, based on a regression analysis to filter out the environmental effects. From these data, static and dynamic monitoring features were extracted. Data were decomposed into their reversible and non-reversible components, the latter being associated to active damaging processes and the residual structural performance of the two buildings.

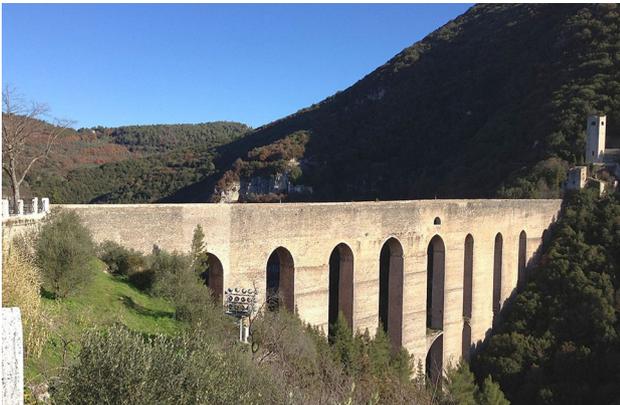
Fig. 8 The *Ponte delle Torri* at Spoleto, Italy [32]

Roselli et al. [32] report the results of the study carried out on the *Ponte delle Torri* at Spoleto, Italy (Fig. 8). The effects of the seismic sequence, which struck Central Italy from August 2016 to January 2017, on the structural health of the structure were analyzed by comparing the ambient vibration measurements before, during and after the seismic sequence. The changes in the dynamic characteristics of the structure were pointed out. They could be an index of the damage evolution. Environmental data were acquired simultaneously with the vibration ones, to account for the seasonal effects on the dynamic behavior. A preliminary finite element model allowed obtaining a first glance at the modal shapes and to choose the sensor locations. A more detailed model was set up after the recordings. High-resolution photos were obtained using an unmanned aerial vehicle and then a 3D reconstruction by structure-from-motion stereo-photogrammetry technique was done. The model was validated through comparison with the damage pattern experienced by the structure. Then, it was used to assess the seismic safety by means of both, non-linear dynamic and static pushover analyses.

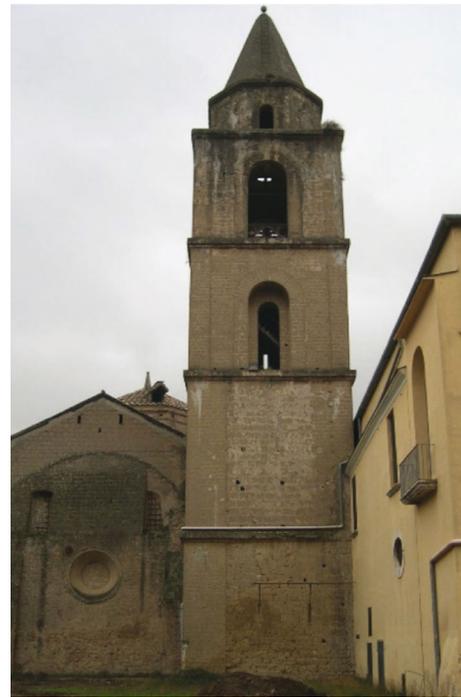
Fig. 9 External view of the Santa Maria a Vico bell-tower [33]

Ferraioli et al. [33] report the most relevant results of the vibration-based investigations performed on a historic masonry tower in Italy, namely the *Santa Maria a Vico* bell-tower (Fig. 9). The first part of the study involves preliminary full-scale ambient vibration measurements in operational conditions and finite element modelling. A manual tuning of the uncertain parameters of the model was first carried out to adjust material properties, soil-structure interaction and constraining effects of the neighbouring structures. Then, a sensitivity analysis allowed choosing the updating parameters. Finally, a model updating technique, based on a sensitivity-based method, was used to minimise the error between the experimental vibration data and the numerical response values. The uncertain structural parameters of the finite element model were identified by minimising a robust penalty function.

The calibrated model was used for the seismic assessment of the structure, which was performed by means of a pushover analysis. A sensitivity analysis was carried out for the masonry compression strength, considering

reference values in the range of interest, which was the most sensitive parameter of non-linear behaviour. Finally, the seismic safety corresponding to increasing levels of the seismic hazard was investigated.

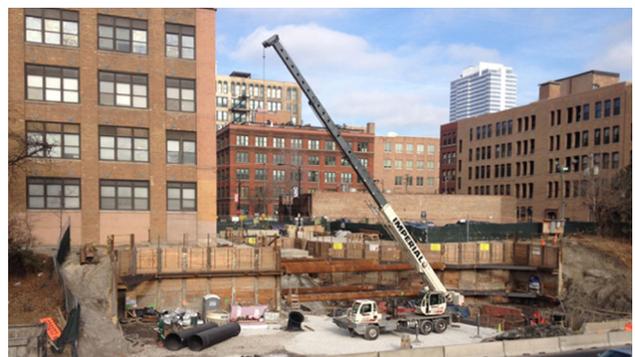
Fig. 10 The historical building at Chicago and excavations adjacent to it [34]

Nazarian et al. [34] propose a methodology based on artificial intelligence. They introduced different Machine Learning approaches (the Support Vector Machines, the Neural Networks and the Gaussian Naïve Bayes) for assessment of damage in the structural elements in large buildings. The method utilizes bending strains obtained by loading of structural members to quantify and localize the

structural damage. The robustness of the methodology was evaluated by means of a numerical analysis, which ensured that the method is capable of identifying the location and intensity of damage with a prediction accuracy of over 86% and a sensors noise level within 8%. The proposed approach was then used in the monitoring and experimentations of a historical building located in Chicago, Illinois, which was built in early 20th century (Fig. 10). The exterior of the building includes masonry columns and walls; the interior of the building utilizes pinned timber frames to support the gravitational loads. The structure was damaged because of the differential settlement of the foundation due to excavations adjacent to it.
