Seismic performance of masonry walls retrofitted with steel reinforced grout

ABSTRACT

Innovative solutions for the seismic protection of existing masonry structures are proposed and investigated through shake table tests on a natural scale wall assemblage. After a former test series carried out without reinforcement, the specimen has been retrofitted using Steel Reinforced Grout (SRG). The strengthening system comprises connectors and horizontal strips of ultra-high strength steel cords externally bonded to the masonry with hydraulic lime mortar, within the thickness of a plaster layer. Natural accelerograms have been applied with increasing intensity up to failure. Test results provide a deep understanding of the effectiveness of SRG for improving the out-of-plane seismic capacity of masonry walls, in comparison with traditional reinforcements with steel tie-bars. The structural implications of the proposed solution in terms of dynamic properties and damage development under earthquake loads are also discussed.

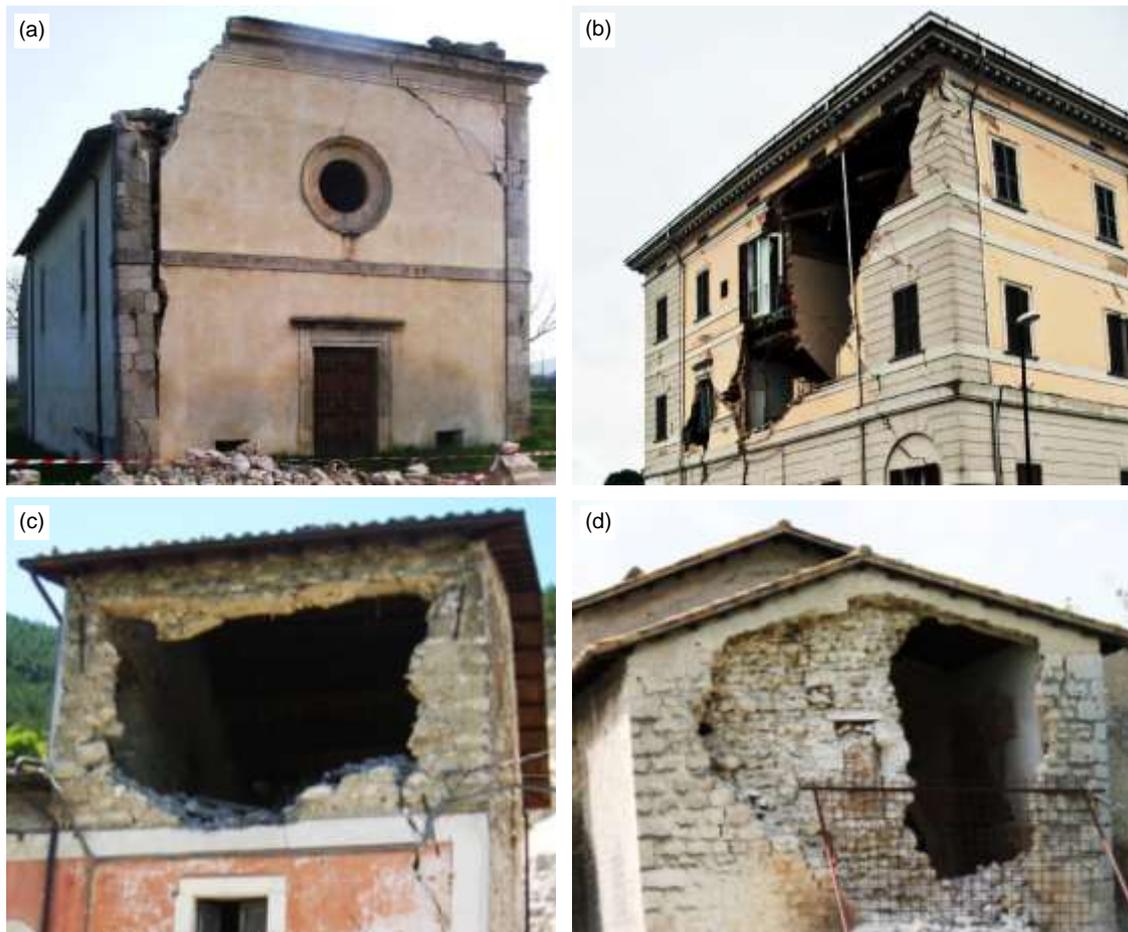
Figure 1. Damage due to out-of-plane seismic loads on masonry buildings: (a) detachment of the façade and (b) collapse by bending in unreinforced masonry walls, (c) failure by bending in the presence of steel tie-bars and (d) reinforced concrete curbs. Photographs (a), (c), (d) are taken after 06/04/2009 L'Aquila, Italy, earthquake. Photograph (b) is taken after 20/05/2012 Emilia, Italy, earthquake.

the failure by out-of-plane bending, especially for slender masonry walls (Figure 1(c)). Reinforced concrete bond beams have been used in the last decades to provide a box-type behaviour and a higher bending capacity to the walls, but in some cases the resulting stiffness discontinuity and the lack of proper connection have even caused the collapse of the masonry below the concrete beam (Figure 1(d)).

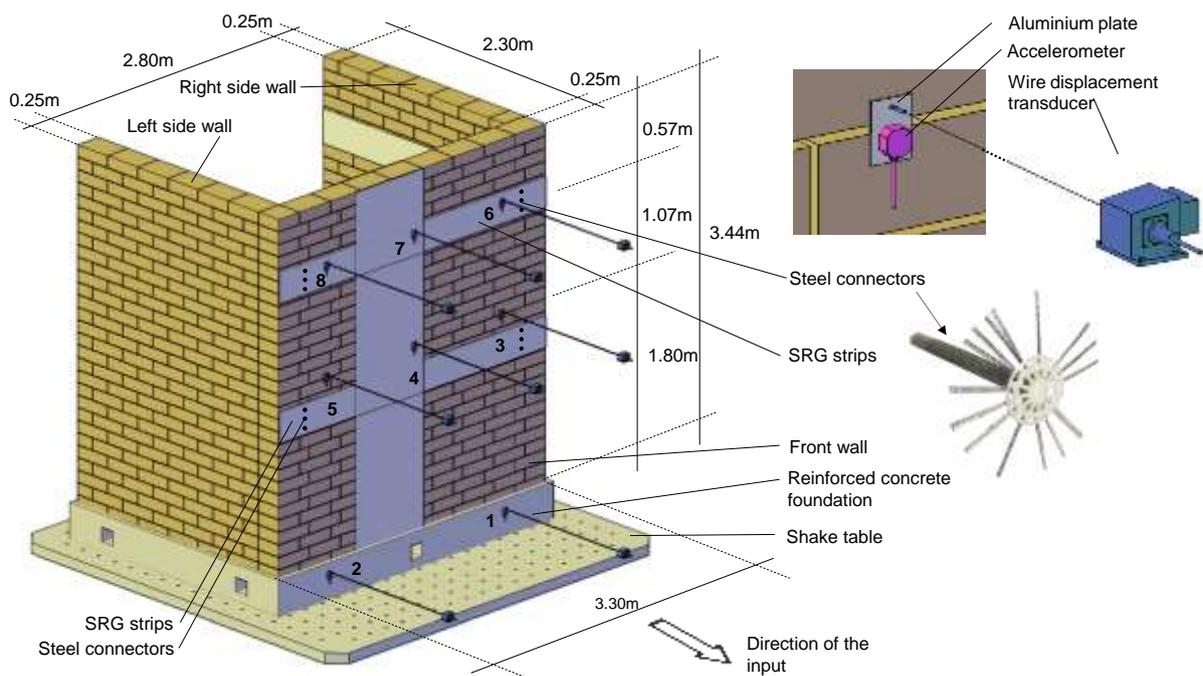
Figure 2. Specimen under study and test setup.

The specimen was a full-scale U-shaped masonry wall, consisting in a façade and two transverse walls (Figure 2). The façade was 3.30m long, 3.44m high and 0.25m thick; the transverse walls had the same thickness and height of the façade and were 2.30m long. The wall was made up of 250mm×370mm×110mm tuff units and hydraulic lime mortar. The tuff had the following mean properties: 12.1kN/m³ unit weight, 5.9N/mm² compressive strength and 1575N/mm² Young's modulus. The mortar had a mean compressive strength of 4.1N/mm², a Young's modulus of 2030N/mm² and a tensile strength (from three point bending tests) of 0.8N/mm². The wall was built on a reinforced concrete foundation having a 0.35m×0.35m cross section, and the first layer of masonry was partially laid in it. Historic masonry buildings may suffer from a poor connection between façade and transverse walls, due to the weak mechanical properties and the deterioration of the materials (mortar and units), to the morphology of the walls (small stones, large mortar joints, irregular arrangement), to damage development and, finally, to the juxtaposition of walls built at different times. In order to simulate such weak connection between façade and transverse walls, which is one of the main causes of the seismic vulnerability of historic masonry buildings, the specimen was realized without block interlocking; the walls were simply built next to each other and a mortar joint was laid between them at the corners. On the contrary, a certain connection would cause diagonal cracks propagating from the base hinge in the side walls, some portions of which would thus rotate with the front wall. The weight of these portions would have a stabilizing

The instrumentation installed on the specimen is shown in Figures 2 and 4. One piezoelectric accelerometer and one wire linear potentiometer were installed by means of steel pivots drilled into the masonry at six measurement points on the front wall (three at the height of 1.80m and three at 2.87m), while two additional measurement points were placed on the foundation. Accelerometers had $\pm 10g$ range, $< 2\%$ accuracy and $0.01g$ resolution. Displacement transducers had 635mm range, 0.2% accuracy and $1\mu m$ resolution, and were anchored to a steel frame placed outside the reaction mass area of the shake table, in order to prevent measurements from being affected by floor vibrations. The strains in the reinforcements were recorded through four resistive strain gauges (10mm length, $< 0.05\%$ accuracy and $1\mu\epsilon$ resolution), glued directly on the textiles and embedded into the mortar matrix, to prevent the measurements from being influenced by mortar cracking [17]. A small resin plate was realized to glue the device to the steel cords, in order to ensure proper adhesion and, consequently, a suitable accuracy in the measurement.

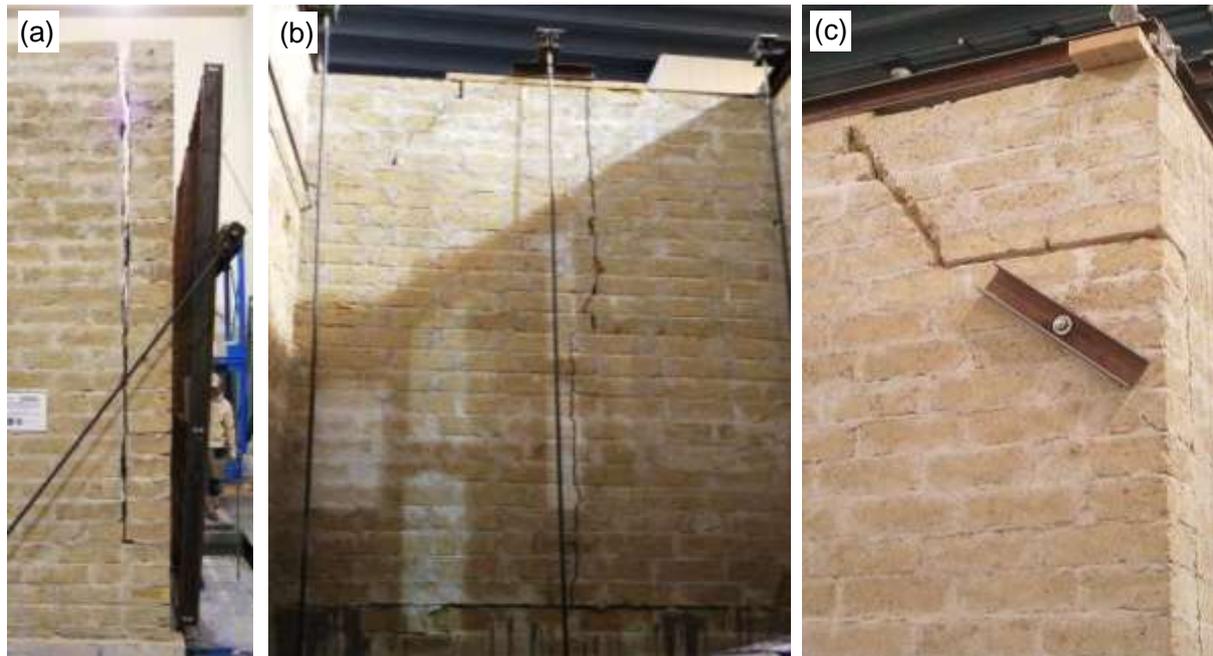
Figure 3. Damage pattern induced by the shale table test series prior the installation of SRG reinforcement [23]: (a) vertical crack at the corner separating the façade from the side walls, (b) vertical crack in the middle of the front wall, and (c) diagonal cracks in the vicinity of the steel end-plates.

A further test series was carried out on the specimen retrofitted with steel tie-bars, which impeded the collapse of the façade. The resulting damage pattern comprised two vertical cracks, one per side, dividing the façade from the transverse walls (Figure 3(a)), and a horizontal crack at the fourth mortar bed joint (at about 0.44m from above the foundation, and all along specimen width), which had previously constituted the overturning hinge of the unreinforced wall (Figure 3(b)). The specimen reinforced with the tie-bars also showed the development of a vertical crack in the middle section of the façade, induced by the out-of-plane bending and by the impacts occurring at the corners during motion. In addition, some diagonal cracks formed at the top and mid-height of the front wall, probably related to the punching effect of the end-plates (Figure 3(c)).

Finally, due to the intensity of seismic input and the limited thickness of the masonry wall, several diagonal cracks appeared on the façade, and the one in the vicinity of the steel end-plates, which already formed during the previous experimental study (Figure 3(c)), and was filled with mortar within the retrofitting works, reopened (tag 6 in Figures 9(b) and 10(a)). However, despite the overall severe damage, no portions of relevant size fell down.

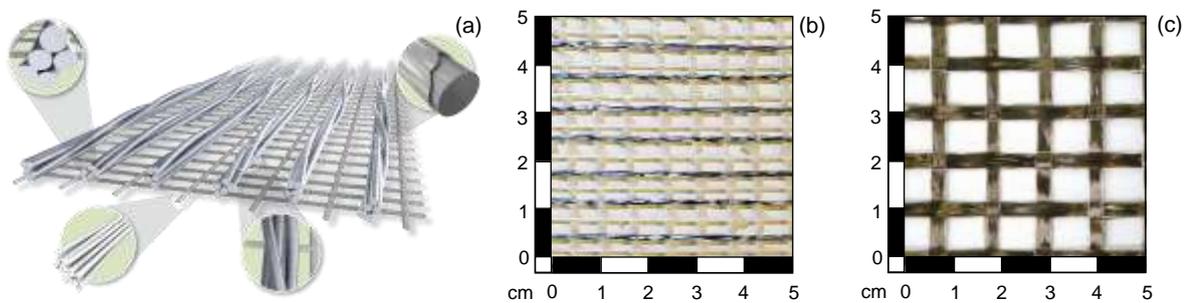
Figure 5. Reinforcement textiles applied for the seismic retrofitting: (a) galvanized ultra-high tensile strength steel (UHTSS) cord detail and (b) unidirectional textile, (c) slate-stainless steel bi-directional mesh.

1151N/mm² tensile strength (corresponding to 62.1kN/m strength per unit width), 275.1kN/mm² Young's modulus, and 1.61% strain at rupture. This fabric can well be used for diffused applications to damaged wall surfaces, because it is bi-directional (thus contributing to the strength increase in the two orthogonal directions) and is produced and stored in wider strips (800mm).

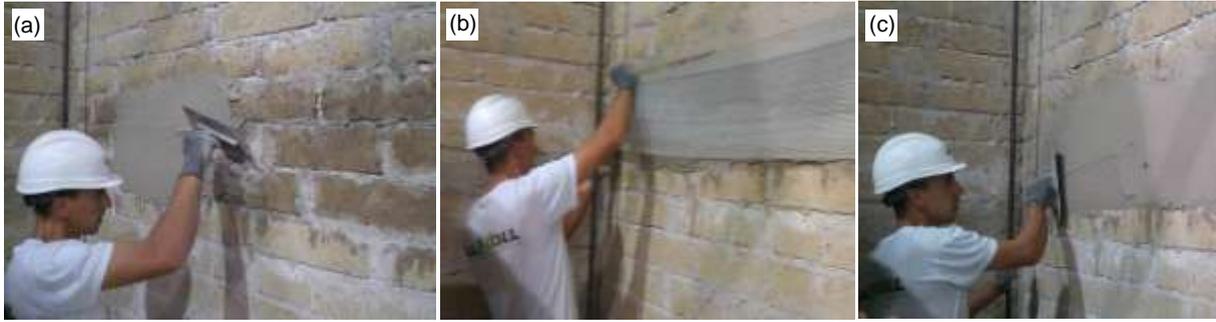
Figure 6. Installation of SRG reinforcement: (a) laying of the first layer of hydraulic lime mortar on the consolidated substrate, (b) application of the steel textile, and (c) laying of the covering mortar layer.

The installation required two working days of two specialised workmen. First, the old mortar in existing cracks was removed and cracks were injected with a natural hydraulic lime (NHL) based fluid grout to restore the continuity of the masonry and prevent impacts during motion. In order to consolidate the tuff substrate and remove dust, an aqueous solution of potassium silicate was applied prior to the laying of the first mortar layer (Figure 6(a)). Then, the slate-stainless steel nets and the SRG strips were installed on the façade to provide tensile strength across the cracks and contribute to the bending strength of the diffusely damaged wall. Two 300mm wide strips of UHTSS cord textile were applied to the internal surfaces all along each transverse wall at the same height of the external SRG bands. While the first mortar layer was still fresh, the textiles were installed and pressed into the fresh mortar, which protruded through all the perforations between cords (Figure 6(b)). The second layer of mortar was then applied (Figure 6(c)). The overall thickness of the reinforcement was 7-8mm. In the vicinity of the façade, each strip was split into three portions in order to obtain the connectors, which were passed through $\varnothing 30$ mm holes drilled in the front wall (Figure 7(a)). Consequently, each of the 12 connectors was made out of a 100mm wide band of steel textile. On the outer side, the connectors were unfold for a length of 100mm, out of the SRG horizontal band (Figure 7(b)), and fixed by means of resin wedges (Figure 7(c)), while the mortar was still fresh. Finally, the holes were injected with a NHL based fluid grout (Figure 7(d)). The externally bonded reinforcement was kept wet for the first 24 hours after installation. Subsequently, the specimen was stored in laboratory conditions (15-20°C and 50-60% R.H.) for about 40 days before testing.

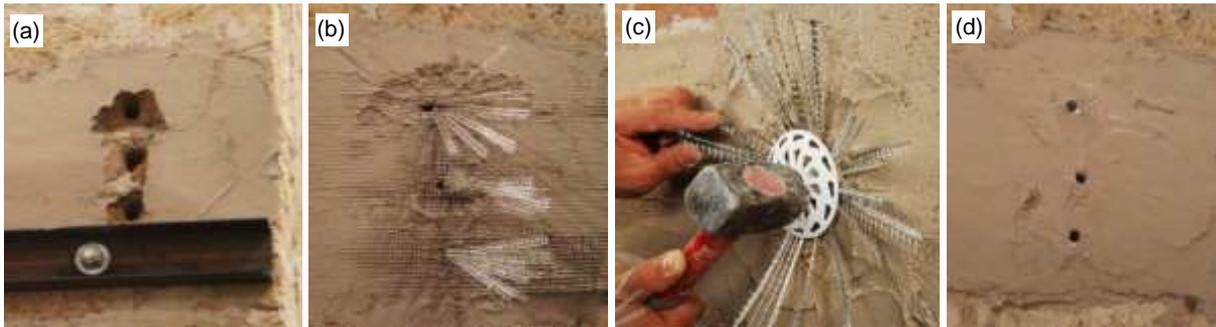
Figure 7. Installation of the steel connectors on the façade: (a) drilled holes through the wall and the horizontal SRG strip, (b) unfolding of the connectors, (c) installation of the wedges, and (d) mortar finishing prior to injecting.

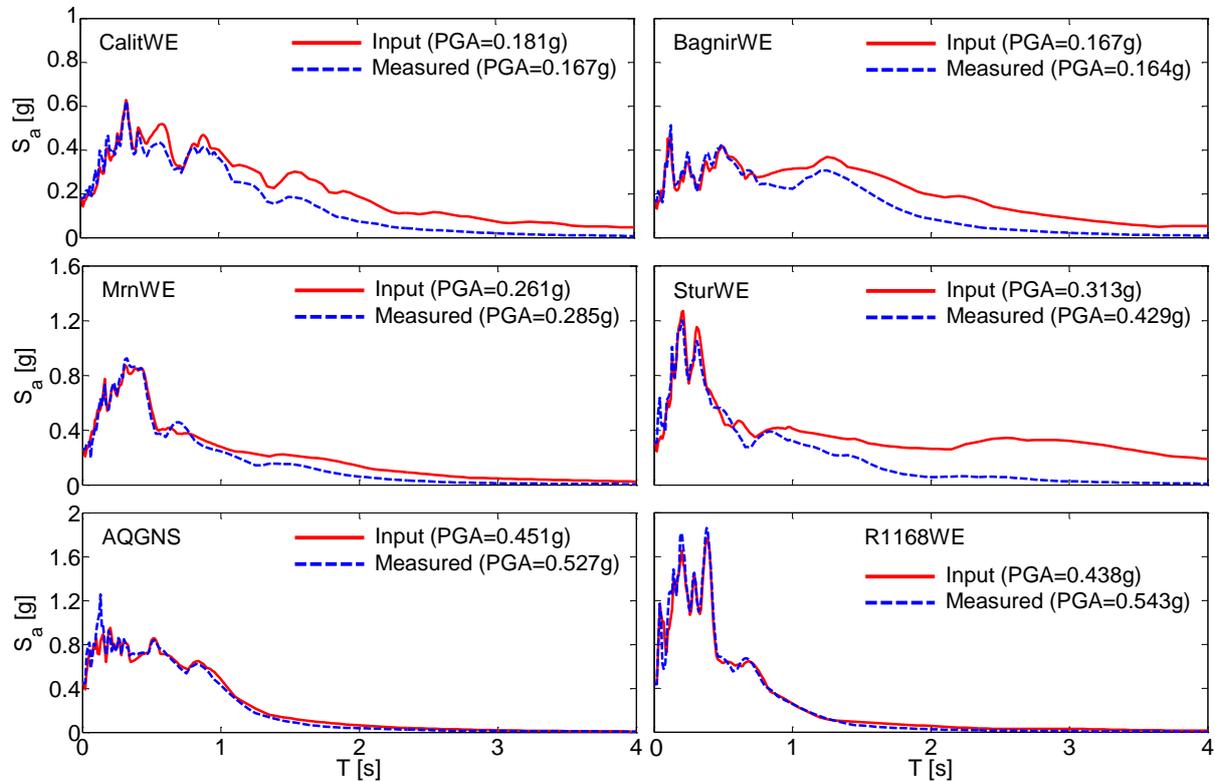
Figure 8. Response spectra of the signals imposed to the shake table and of the accelerations measured by accelerometer #1 on the reinforced concrete foundation of the specimen (tests with SF=1).

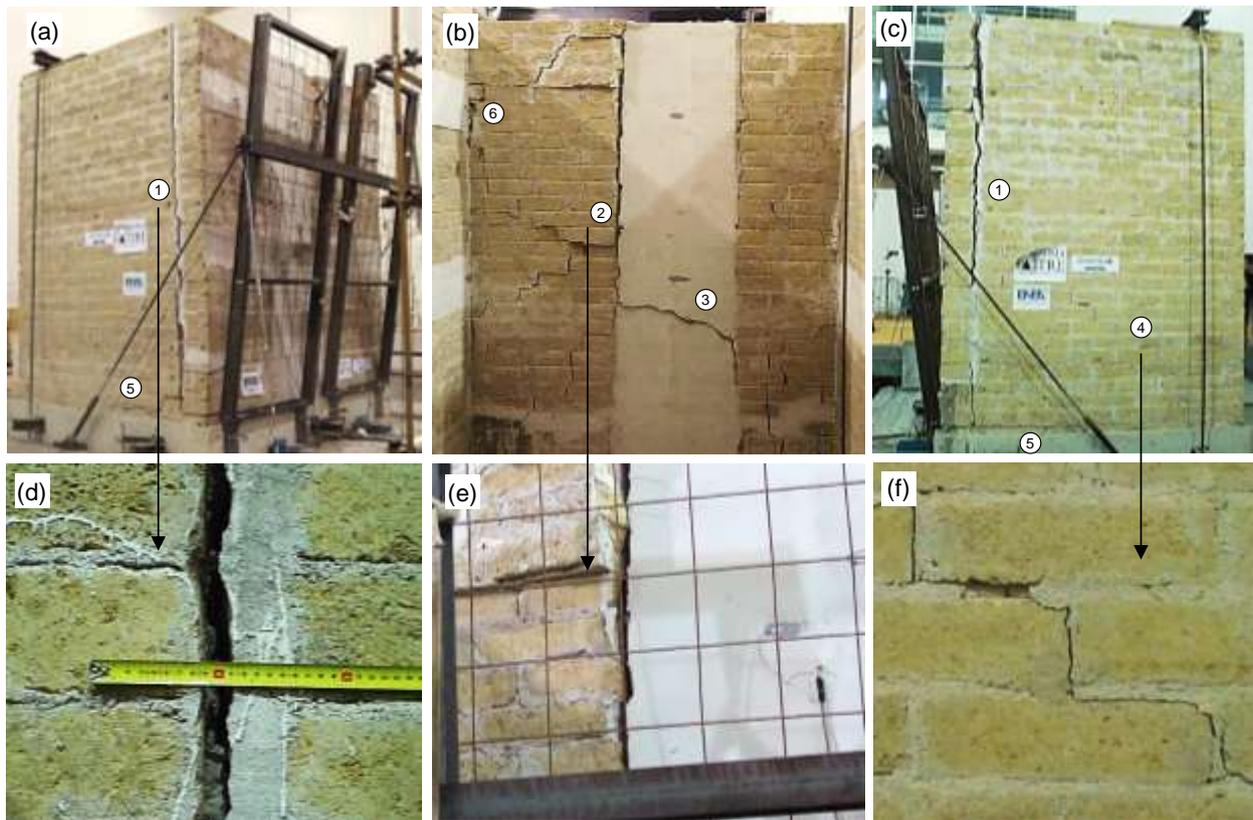
Figure 9. Retrofitted specimen after failure: (a) vertical cracks at the corner separating the façade from the side walls, (b) damage in the internal side of the front wall, (c) damage in the side walls, details (d) of the crack between façade and left side wall, (e) of the vertical crack induced by bending in the middle of the front wall, and (f) of the diagonal crack produced by in-plane loads on the right side wall.

The last test (TH 57) was carried out under Nocera-Umbra record amplified by a factor of 2.5, and the acceleration recorded on the foundation had 1.51g PGA and 584mm/s PGV. After this test, the specimen was considered failed due to the severity of damage (shown in Figures 9 and 10). Though the masonry of the façade was completely separated from the transverse walls (tag 1 in Figures 9(a), 9(c), 10(c) and 10(d)), and the vertical crack displayed a residual width of about 20mm (Figure 9(d)), the steel connectors did not fail nor were pulled out from the front wall, and the horizontal reinforcements on the side walls did not detach, so no out-of-plane overturning occurred. The maximum stress on the connectors recorded during the test was 344N/mm² (Table A), which is well below the tensile strength (3208N/mm²) of the steel textile. Such a large safety factor toward tensile failure was assumed in the design to prevent both the pull-out failure of the connectors and the debonding of the SRG strips installed on the side walls.

Despite the severe vertical bending experienced by the façade, outwards failure was prevented by the horizontal SRG strips installed on the external side of the wall. On the contrary, the absence of horizontal SRG strips in the internal side led to the development of a vertical crack dividing the wall into two portions, which rotated inwards around the connectors (tag 2 in Figures 9(b), 10(a), and 10(b), and Figure 9(e)), cutting the slate-steel net (tag 3 in Figures 9(b) and 10(b)).

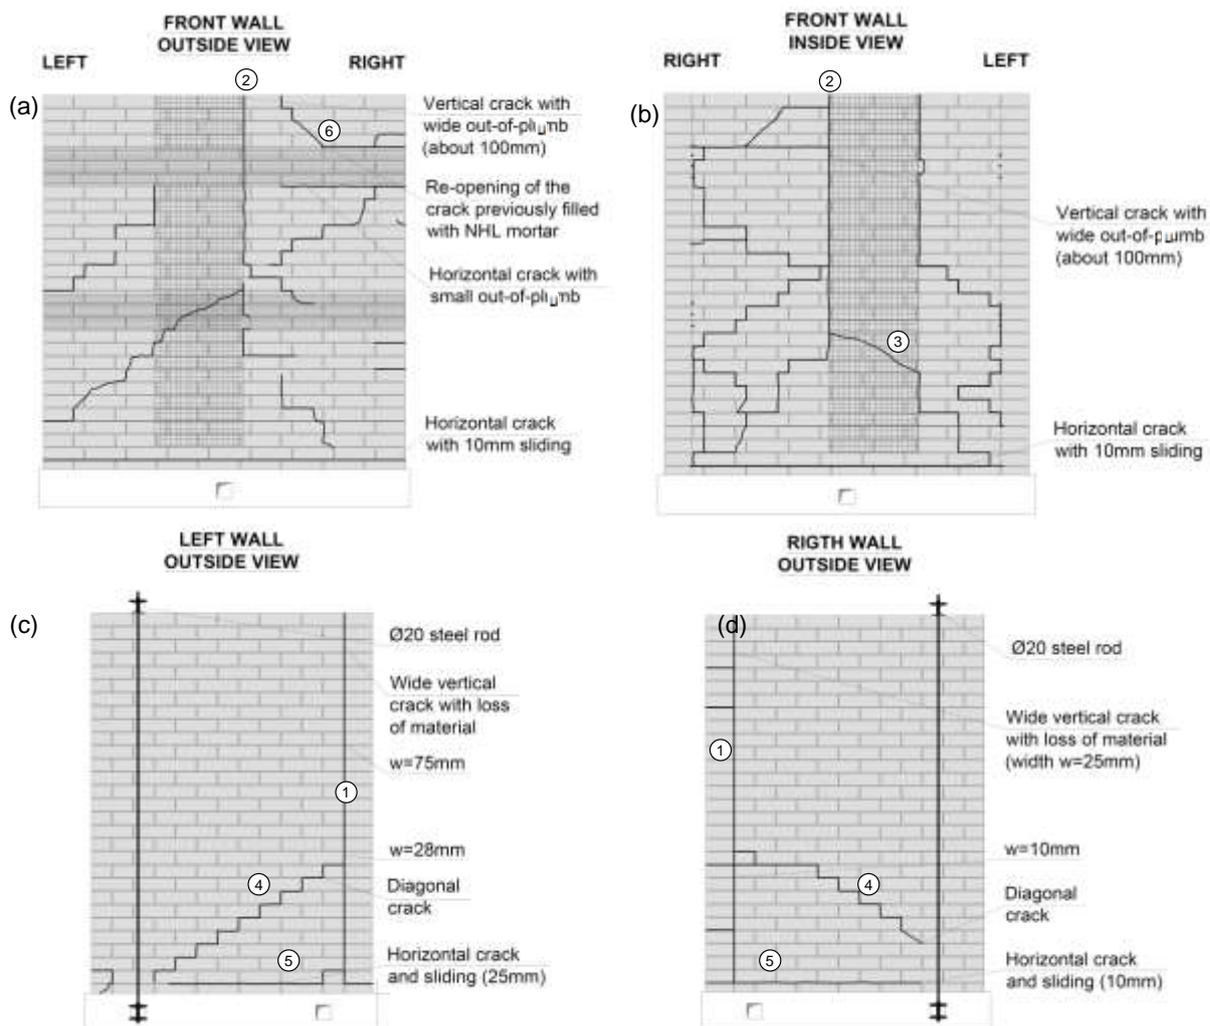
Figure 10. Survey of the crack pattern after failure: (a) outside and (b) inside view of the front wall, outside view of (c) left and (d) right walls.

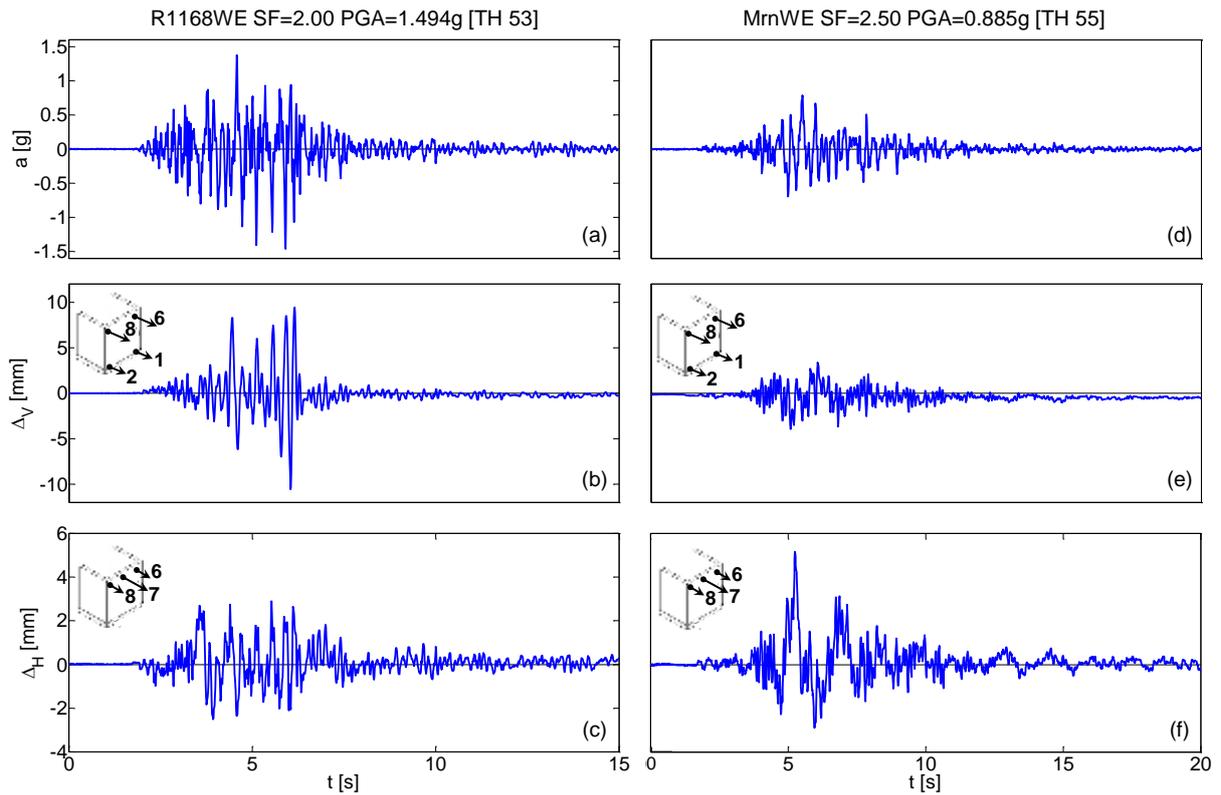
Figure 11. Time histories recorded during tests under (a,d,e) R1168WE with SF=2.00 and (b,d,f) MrnWE with SF=2.50: (a,d) earthquake base acceleration, (b,e) vertical bending (Δ_V), and (c,f) horizontal bending (Δ_H).

The Time Histories (TH) recorded during two strong inputs, namely TH 53 and TH 55, are shown in Figure 11. Graphs 11(a-c) show the response to 2009 Nocera Umbra record, amplified with a SF of 2.0 (TH 53), corresponding to a PGA of 1.494g (Figure 11(a)). The relative displacement Δ_v , measuring the vertical bending, reached 11mm (Figure 11(b)), while the maximum relative displacement of the centre of the façade with respect to the corners (Δ_h), which is related to horizontal bending, was about 2.5mm (Figure 11(c)). The opening of the vertical cracks separating the façade from the transverse walls was more evident at the left corner, where a relatively high stress (σ_3) was recorded by the strain gauge on the connector. As a result of crack opening, the

connection was more deformable than in the previous tests (see the columns of $\max|\Delta_V|$ and $\min|\Delta_V|$ in Table A). A certain rotation of the front wall around the connectors was allowed from this moment on, and the open joint allowed for impacts to occur during motion, as revealed by the negative (inwards) peaks in the displacement time history. Figures 11(d-f) show the response to MrnWE record amplified by SF=2.5 (TH 55, PGA=0.885g). Despite the higher scale factor, the response of the specimen in terms of vertical bending was lower (Figure 11(e)) than in the previous case, because all the intensity measures of the natural (unscaled) record (namely, PGA, VSI and S_a) were lower (Table I). Conversely, the horizontal bending displacements were higher (up to 5.5mm, Figure 11(f)), indicating that damage was developing in the middle of the front wall.

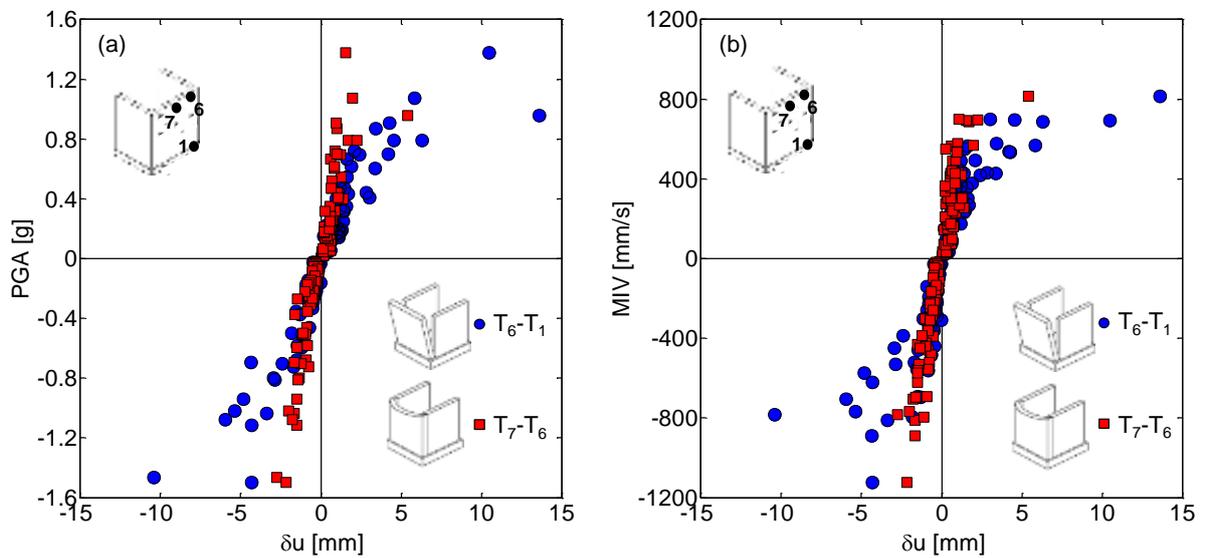
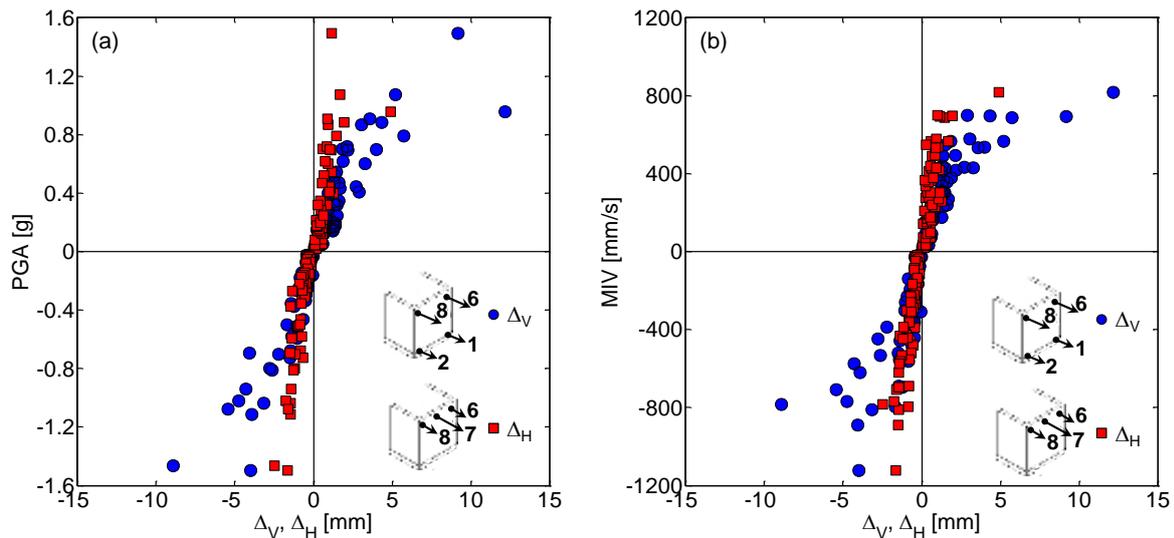
Figure 12. Relative displacements associated to vertical bending (Δ_V) and horizontal bending (Δ_H) vs. (a) peak ground acceleration (PGA) and (b) Maximum Incremental Velocity (MIV).

The response of the specimen to all the shake table tests is represented in Figure 12. The relative displacements related to vertical and horizontal bending (Δ_V and Δ_H) are on the x-axis, while the peak ground acceleration (PGA) and the Maximum Incremental Velocity (MIV) are on the y-axis for Figures 12(a) and 12(b), respectively. As a general trend, the response is practically linear up to a PGA of about 0.5g and a MIV of 400mm/s. Then, some damage, as shown by the loss of linearity in the relationship between input and response measures. Displacements associated to vertical bending were generally larger than those of horizontal bending, especially for strong inputs, which caused progressive crack development and crushing (with loss of mortar) in the vertical joints at the corners. On the contrary, the SRG strips bonded to the façade limited deformations and damage, which appeared only in the last round (with SF=2.5).

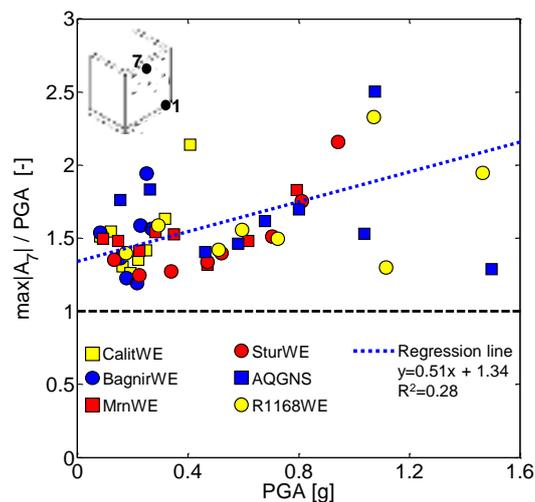
Figure 13. Amplification of acceleration at the top (accelerometer #7) vs. PGA on the foundation (accelerometer #1).

The seismic action experienced by the structure at a certain height from the foundation depends on the filtering effect produced by the building through which the seismic input propagates [29]. Based on experimental data acquired during shake table tests, a measure of the dynamic amplification was derived by the ratio between the maximum accelerations recorded by accelerometers #7 and #1. The obtained values are illustrated in Figure 13 and are comprised between 1.50 and 1.70. The slight trend upwards, shown by the slope of the regression line, may indicate a certain progressive accumulation of damage. However, the large scatter ($R^2=0.28$) indicates that, on the base of available experimental measurements, no clear relationship can be established between dynamic amplification and input PGA.

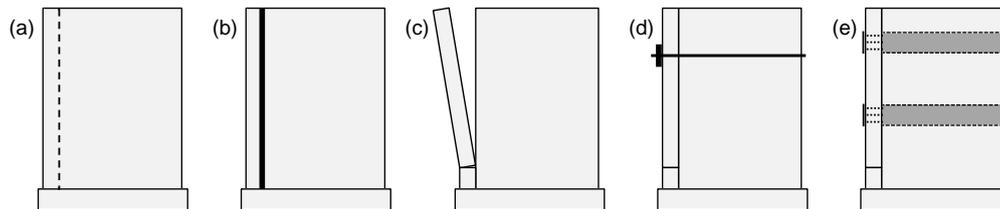
Figure 14. Specimen configurations: (a) undamaged, (b) damaged (cracked without front wall separation), (c) rocking (detached façade), (d) strengthened with steel tie-bars, and (e) retrofitted with SRG.

In order to develop a deeper understanding of the effectiveness of the proposed strengthening solution with steel reinforced grout, the seismic performance of the retrofitted specimen has been compared to that exhibited without reinforcement and with tie-bars. More specifically, the following five configurations have been considered (Figure 14):

- (a) undamaged (unreinforced, before crack development),
- (b) damaged (façade detached from the side walls, before collapse),
- (c) rocking (after out-of-plane overturning of the façade, behaving as a rigid body under rocking motion),
- (d) reinforced with steel tie-bars,
- (e) repaired/retrofitted with SRG.

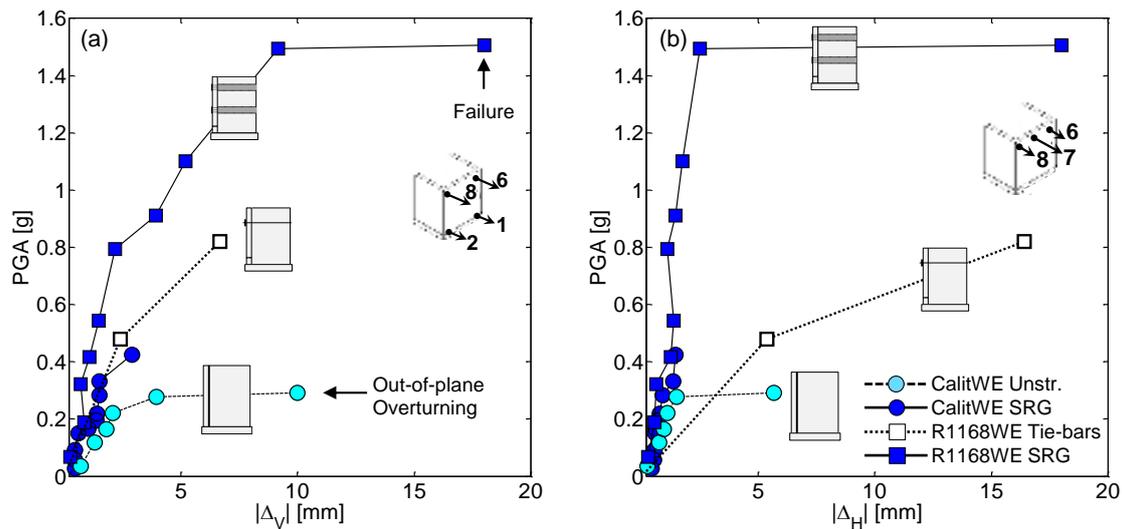
Figure 15. Comparison between different reinforcement solutions (unreinforced, steel tie-bars, and SRG) in terms of seismic capacity: (a) PGA vs. vertical bending (Δ_V) and (b) horizontal bending (Δ_H).

The comparison in terms of seismic capacity among the unreinforced specimen and different strengthening solutions (namely, steel tie-bars and SRG) is shown in Figure 15, having the recorded PGA on the y-axis, and either the vertical bending (Δ_V , Figure 15(a)) or the horizontal bending (Δ_H , Figure 15(b)) on the x-axis. The out-of-plane overturning of the unreinforced wall occurred under CalitWE signal with a PGA of 0.291g. Apart from the last test (in which overturning occurred), the maximum relative displacement was nearly 5mm for PGA=0.277g. The same record was applied to the retrofitted specimen up to a PGA of 0.424g, and lower relative displacements were measured. R1168WE signal applied with PGA=0.82g on the wall with the steel tie-bars induced a severe damage, though not a proper failure (as described in section 2.1). A much higher PGA (1.507g) caused the failure of the specimen retrofitted with SRG, which showed smaller relative displacements at similar input intensity values. The comparison in terms of horizontal bending shows that both the unreinforced wall and that retrofitted with and SRG displayed a strong increase in the relative displacement only at failure, while in the specimen strengthened with tie-bars large displacements occurred also well before failure, due to the development of the vertical crack in the middle of the façade. In conclusion, assuming the PGA as a reliable indicator of the input intensity (Figure 12(a)), the improvement of the seismic capacity provided by the reinforcement with steel-tie bars and with SRG was, in the present case, in the order of 3 and 5 times, respectively.

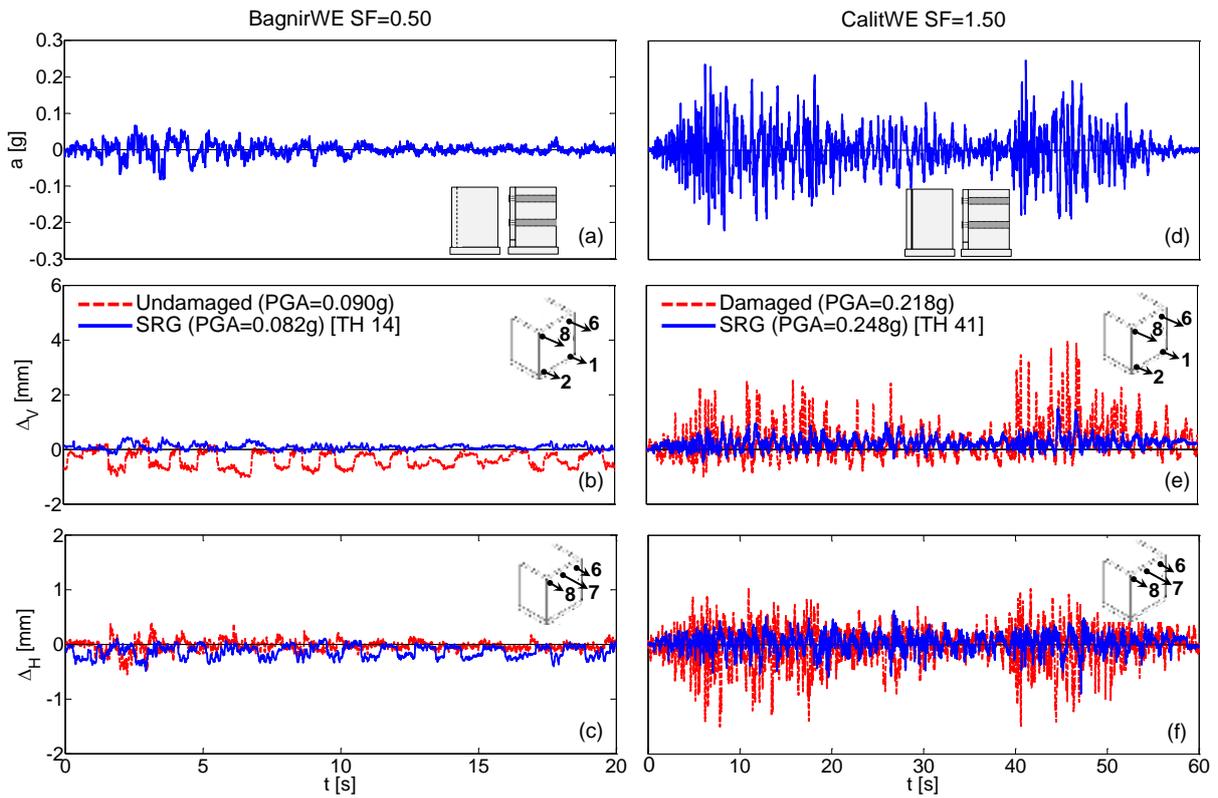
Figure 16. Comparison between (a,b,c) undamaged and SRG specimen configurations under BagnirWE with SF=0.50, and (d,e,f) damaged and SRG specimen configurations under CalitWE with SF=1.50: (a,d) time histories of earthquake base acceleration, (b,e) vertical bending (Δ_V), and (c,f) horizontal bending (Δ_H).

The seismic responses of the different specimen configurations are represented in Figures 16 and 17. The former shows the time histories recorded on the retrofitted wall compared to those acquired on the unreinforced one, before (Figures 16(a-c)) and after (Figures 16(d-f)) cracking. Under BagnirWE record with SF=0.5 (PGA=0.083g, Figure 16(a)), the response of the undamaged and of the retrofitted specimens are similar, especially in terms of vertical bending (Figure 16(c)), while the SRG entails smaller horizontal bending (Figure 16(b)), due to the increased stiffness provided by the horizontal reinforcement strips bonded to the façade. Differently, after damage developed on the unreinforced specimen, much larger relative displacements took place, as shown by the records under CalitWE SF=1.50. The occurrence of cracks, separating the side walls from the façade (which rotated around a base hinge, without overturning), is clearly shown by the displacements associated to vertical bending (Δ_V , Figure 16(e)). Furthermore, the loss of lateral connection at the corners led to impacts during motion, which were responsible for significant horizontal bending during inwards movements, as proven by the negative peaks (up to 1.5mm) of the Δ_H time history (Figure 16(f)). Conversely, in the retrofitted specimen, not only smaller relative displacements, but also a faster damping of oscillations was found (Figure 16(e)).

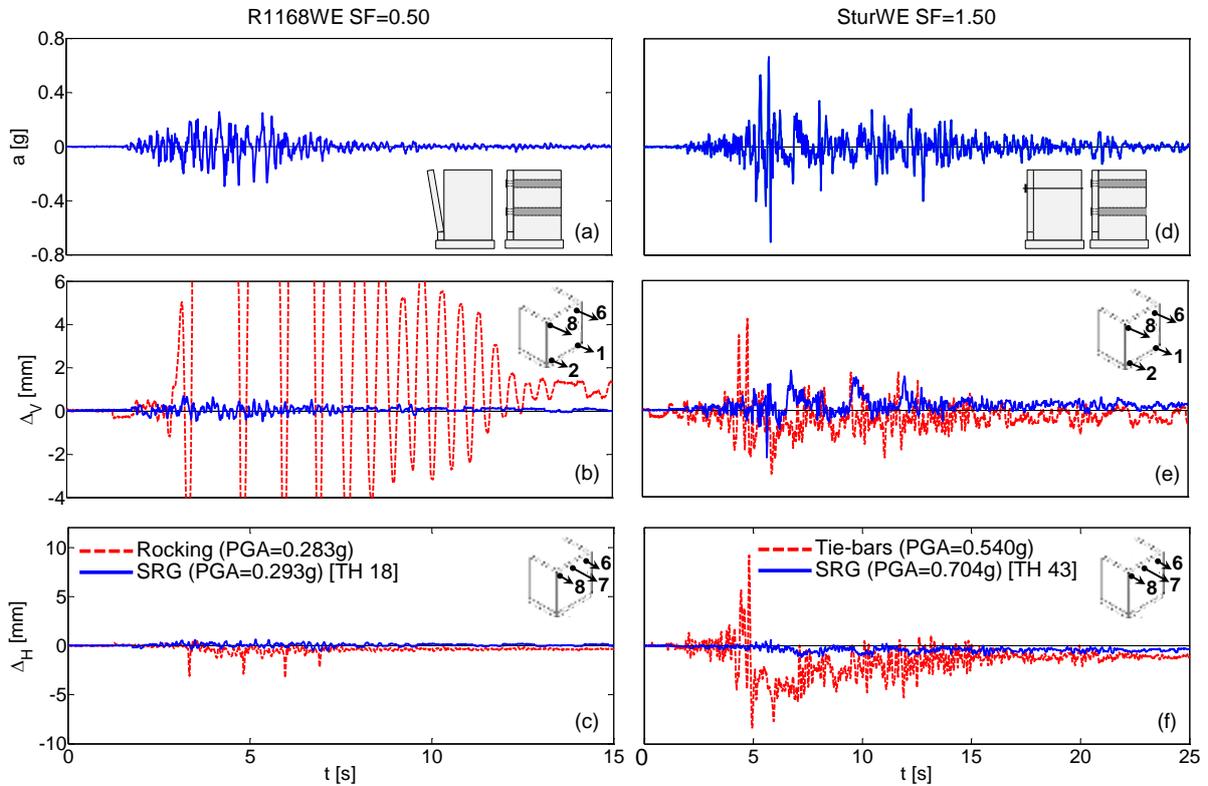
Figure 17. Comparison between (a,b,c) rocking and SRG specimen configurations under R1168WE with SF=0.50, and (d,e,f) tie-bars and SRG specimen configurations under SturWE with SF=1.50: (a,d) time histories of earthquake base acceleration, (b,e) vertical bending (Δ_V), and (c,f) horizontal bending (Δ_H).

The comparison between rocking and SRG configurations is shown in Figures 17(a-c). Apart from the huge difference between Δ_V time histories (Figure 17(b)), which was the obvious consequence of the rocking motion of the unreinforced wall, both the residual displacements (Figure 17(b)) and the bending (Figure 17(c)) were extremely smaller in the retrofitted specimen. In Figures 17(d-f) the response of the specimen retrofitted with SRG is compared to that with steel tie-bars. Despite the significant increase in the seismic capacity, already discussed in the previous section, the wall with tie-bars showed larger relative displacement peaks and larger residual displacements than that with SRG (Figures 17(e-f)). The different damage was a result of the distributed effect of the horizontal SRG strips, of the presence of the bi-directional slate-stainless steel net on both the internal and external surfaces of the wall, and of the filling of existing cracks (including the vertical cracks at the corners) which partially limited the impacts during motion (Figure 17(f)).

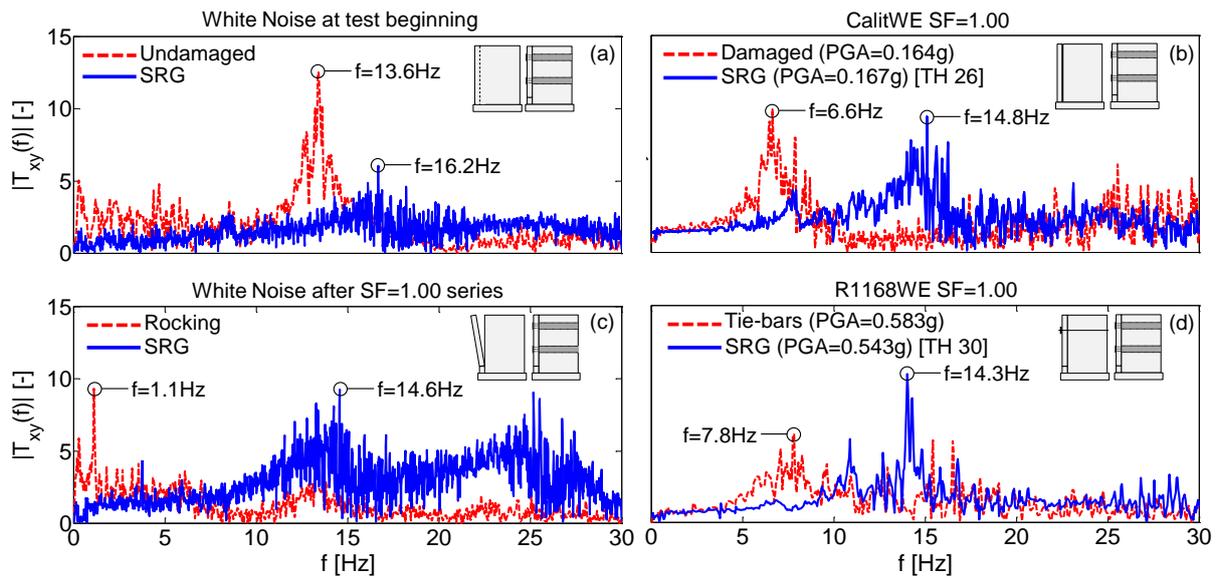
Figure 18. Modulus of the transfer function of the specimen configurations: comparison between SRG and (a) undamaged, (b) damaged, (c) rocking, and (d) tie-bars (rivedi i grafici, metti quelli con il windowing).

The dynamic properties of the five specimen configurations are illustrated in Figure 18 for some sample tests, while the variation along the whole study is shown in Figure 19. For each test, the fundamental frequency was derived from the transfer function (T_{xy}), which represents the filtering effect of the structure expressed through the comparison of the output signal (y) and the input signal (x). Differently from other dynamic identification techniques, such as, for instance, the Discrete Fourier Transform (DFT), the Power Spectral Density (PSD), and the Frequency Domain Decomposition (FDD), the transfer function provides information on the dynamic properties of the structure independently from the frequency content of the input and provides good results for non-stationary input signals. In the present work, the acceleration time histories recorded by accelerometers #1 and #7 were assumed as input and output signals, respectively. $T_{xy}(f)$ is defined as the ratio between the cross power spectral density of x and y and the power spectral density of x . It is a complex function, and its modulus is depicted on the y-axis of the graphs.

Before the beginning of the test series, the fundamental frequencies of the undamaged and retrofitted specimens detected under a white-noise input with 0.05g PGA were 13.6Hz and 16.2Hz, respectively (Figure 18(a)) and correspond to the values obtained from a relatively simple numerical model with shell finite elements [26]. Such increase (from 13.6Hz to 16.2Hz) mainly depended on the steel connectors placed across the vertical joints at the corners, which limited their outwards deformation, and to the horizontal SRG strips bonded to the façade, which constrained its bending deflection. The unreinforced specimen steadily accumulated damage, decreasing its fundamental frequency to 6.6Hz (Figures 18(b) and 19). A comparable sequence of seismic tests caused a much smaller frequency reduction of the retrofitted wall, as it is evident from Figure 18(b), which reveals a peak at 14.8Hz. The wall also exhibited a smaller peak at about 8Hz, which was already visible (though less pronounced) under the preliminary monitoring under white noise, and is related to a modal shape involving the out-of-plane bending of the side walls [26]. The out-of-plane rocking motion of the front wall after its complete detachment has fundamental frequency of about 1Hz (Figure 18(c), [23]), but it should be considered that such an inverted pendulum behaviour is strongly non-linear (i.e., its frequency depends on the amplitude of the oscillations), and, therefore, the results provided by the transfer function are less reliable than for the other configurations. The comparison with the retrofitted specimen is made under a white noise after the SF=1.0 series, and, in this case, the frequency of the wall reinforced with SRG was 14.6Hz. Finally, as indicated by Figure 18(d), the fundamental frequency after the installation of the tie-bars was 7.8Hz and decreased to 5-6Hz after 9 tests (Figure 19). The specimen retrofitted with SRG showed a slower accumulation of damage and its frequency declined to 10-11Hz only during the most severe tests (Figure 19 and Table A).

For the dynamic identification under stationary inputs (white noise, Figures 18(a) and 18(c)), the windowing technique was used to allow for a more reliable identification of the fundamental frequency. Windowing consists in analysing several portions with a certain duration (the width of the window), e.g. 30s, of the input and output signals, starting from different time instants (e.g., 0s, 10s, 20s, and so on). Then, the average transfer function is computed, which is smoother than those of each portion. Windowing cannot be applied to non-stationary signals, such as earthquake records. The fundamental frequencies derived from accelerometers were validated against those provided by other two independent measurement systems, such as a velocimeter placed on top of the wall for HVSR assessment [27] and the abovementioned 3D motion capture system through Operational Modal Analysis (OMA). This latter, also gave information on three-dimensional modal shapes [26,30], which could not be provided by the accelerometers and the wire transducers placed in out-of-plane direction on the façade.

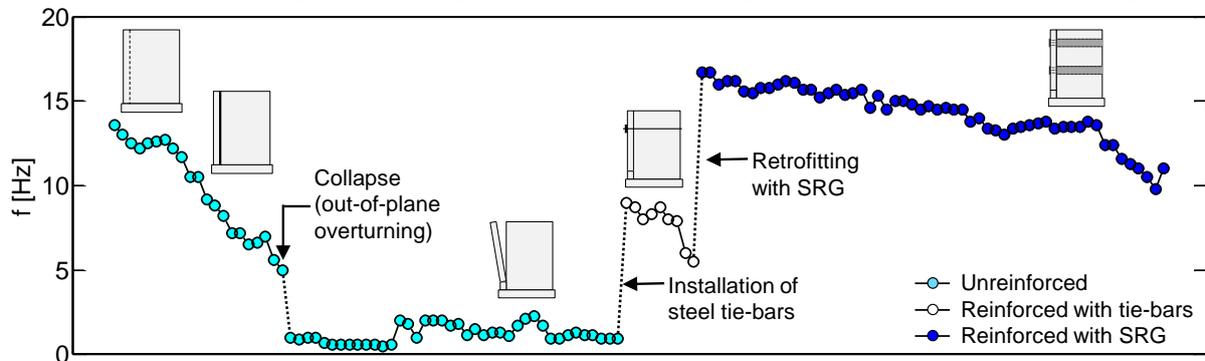
Figure 19. Variation of the predominant frequency during test sequence for all specimen configurations.
